181 Iron

**GENERAL REMARKS.**

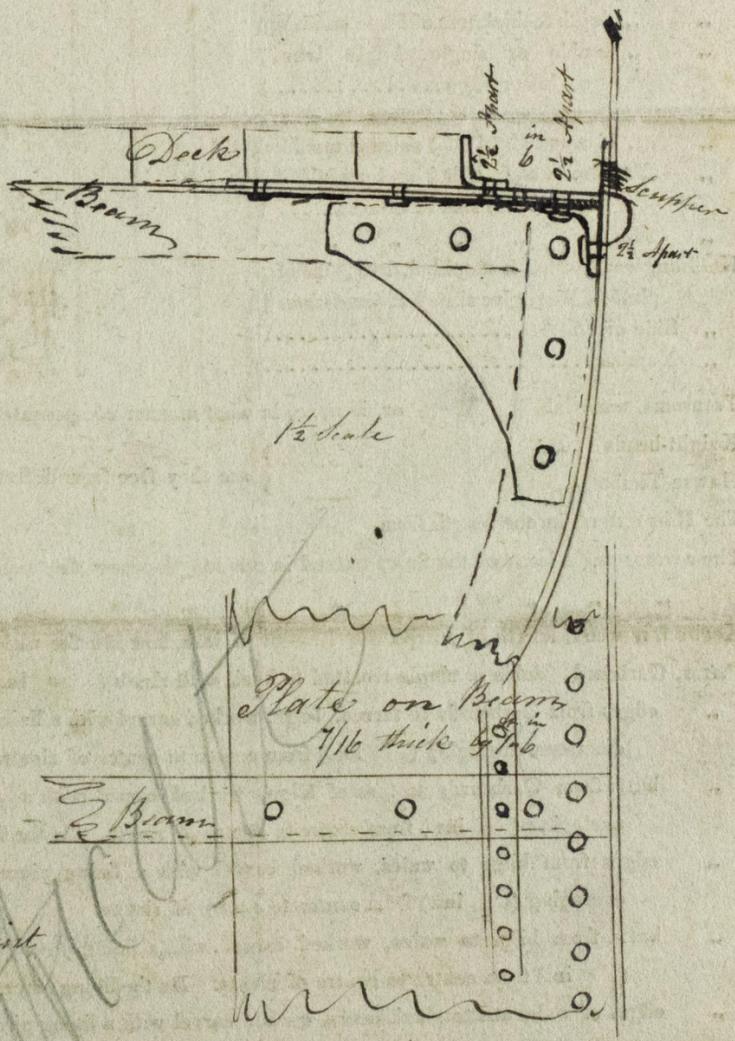
The Beams are well secured to the Side by a Plate <sup>for in</sup> 1 1/2" Broad riveted on the Beams, it also forms the Waterway, as *pl<sup>d</sup>* Sketch, and an Iron plate knee to every other Beam. The Main Hatchway is 12 feet Long and the half Beams in wake of the Hatchway has plate knees the same as whole Beams
