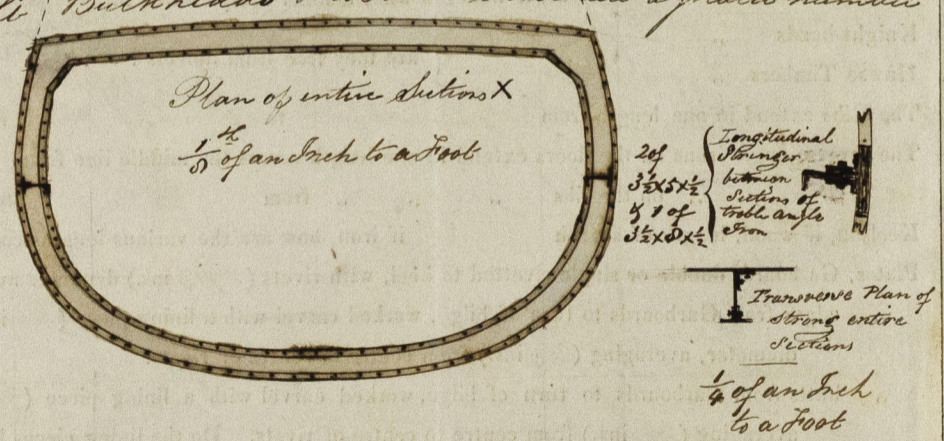
*She has three Water tight Bulkheads entire, of 3/16 to 3/8 Plates stiffened by Angle Iron 4x3x3/8. and three strong entire sections in the main Body of the ship made of Plate Iron 15" deep with double angle Iron at top edge 3x3 1/2, and attached to the sides of the ship and to the Deck forming a continuous section of great transverse strength, and at near 7 feet below the Deck, a stinger of double angle iron has been introduced connected to these sections, home to the ribs, to which it is connected at every Rib with reversed angle iron, and two Hold Beams have been added, the strength here mentioned occupies a length of 76 feet and the stingers are rivetted at their extremities to the perfect water tight Bulkheads these are to substitute a greater number of Hold Beams*
