723 Iron

GENERAL REMARKS.

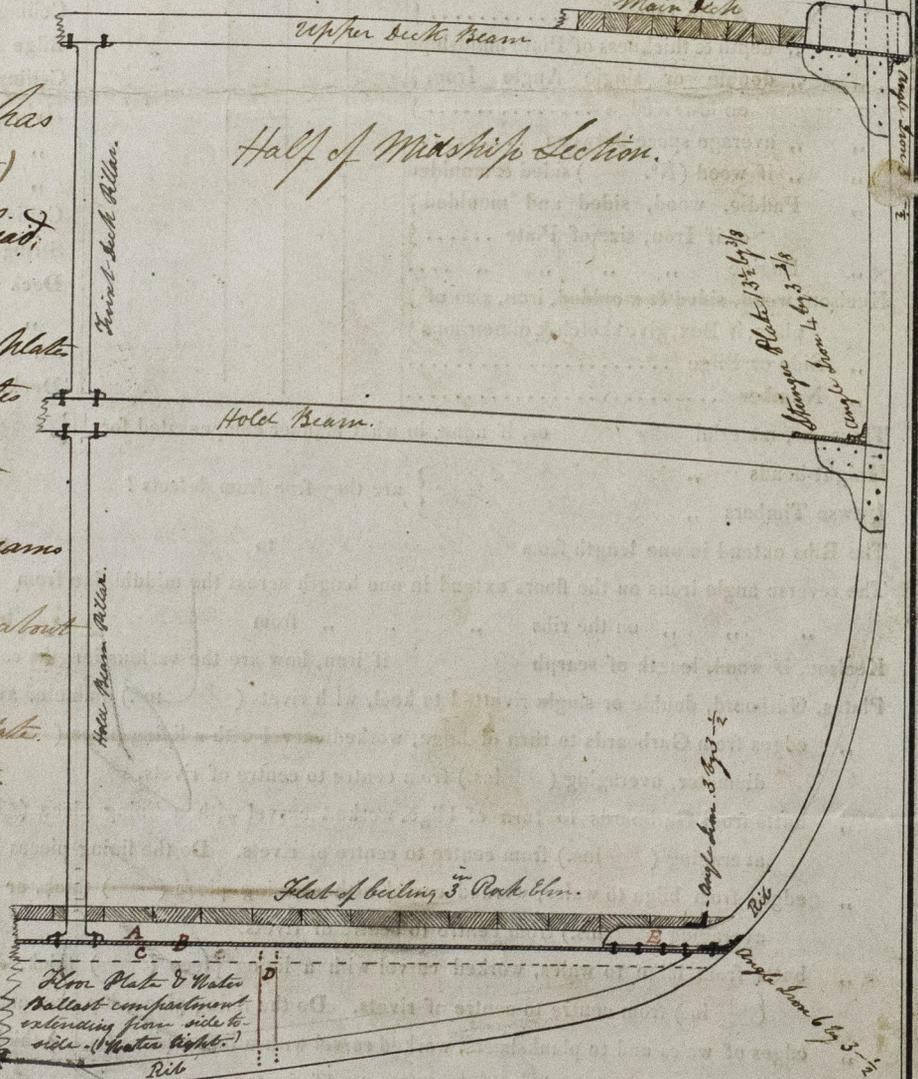
Explanation of letters on Sketch

- A Represents 3" deals laid across the bottom about 4 feet apart & beiling of flat nailed into it*
- B- The inner bottom plates Watertight.*
- C- The reversed angle iron on top of Floor plates.*
- D- Vertical angle iron rivetted to Floor plates.*
- E- Rib overlapping the inner bottom.*
