812 Iron

**GENERAL REMARKS.**

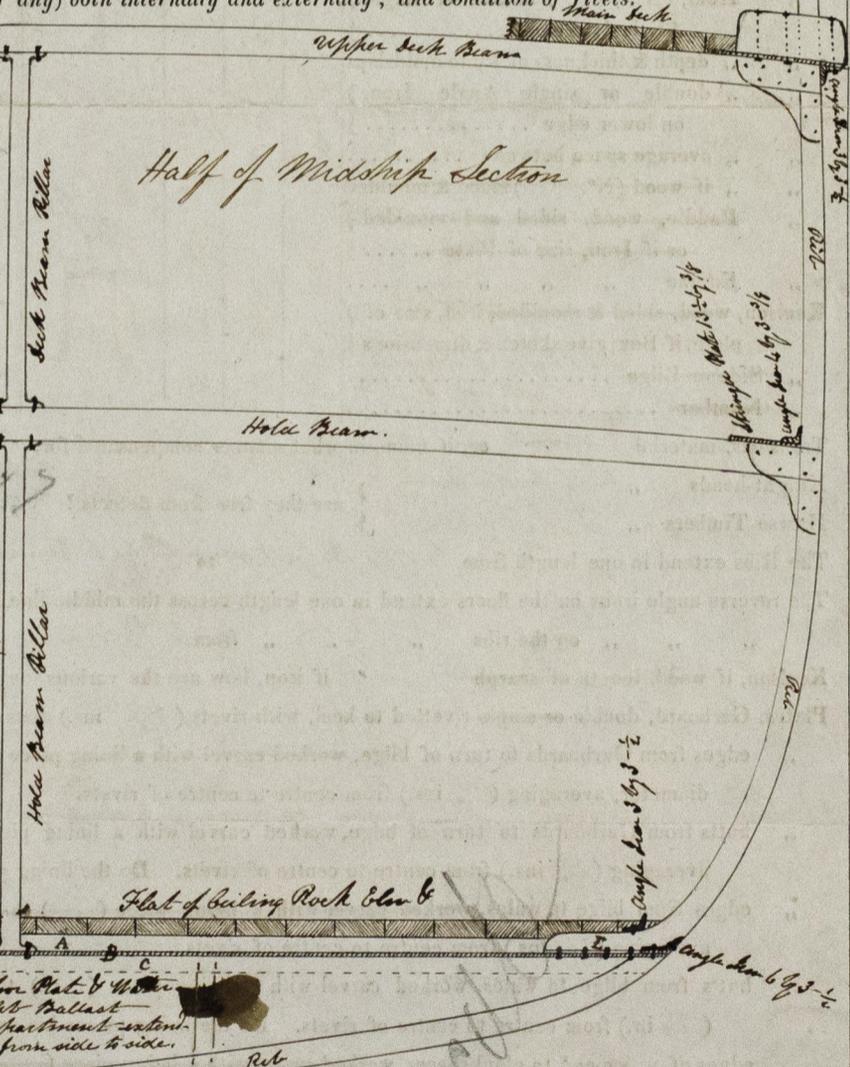
- Explanation of letters on the Sketch*
- A Represents 3 deals laid across the bottom about 4 ft apart & ceiling of flat nailed into it.*
  - B The inner bottom plating Watertight.*
  - C The reversed angle Iron on top of Floor plate.*
  - D Vertical angle Iron rivetted to Floor plates*
  - E Rib overlapping the inner bottom.*
