883 Iron

This Paddle wheel Steamer has been built to carry Passengers from London to Antwerp, was first seen for Classification when far advanced in her build, viz Iron work complete and coated, the Boilers in, and part of Engines fitted, also Rigging and Launching Slip fitted.

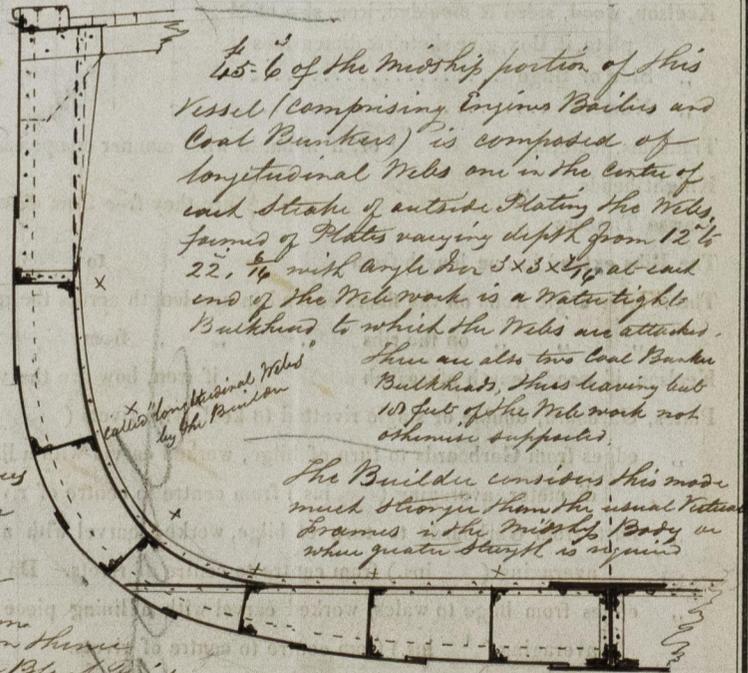
The Web angle Iron have a step between them and the outside Plating through which they are rivetted, these steps are to the thickness of the Butt Plates, and to breadth of angle iron
