REPORT of SURVEY for REPAIRS.

on the Iron Ship "Summer flood" Master William Watson.

Tonnage 698 Built at Hartlepool When built 1859.

Survey held at London Date 11th December 1867.

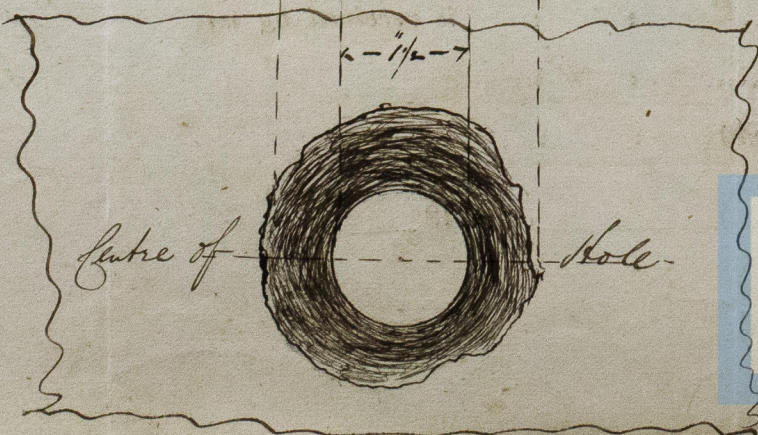
Sketch showing the appearance of the hole from the inside

afloat by constant Pumping. - On arriving at Plymouth the Captain employed a "Diver", who after a careful search found a hole about $1\frac{1}{2}$ ins diameter, in the flat of Bottom on the Portside just abaft the Main-mast, and about four feet from the middle line, and on his driving a wood-plug into it the vessel was rendered quite tight. -

On examining this hole from the outside, with the Ship in dry dock, it presented an appearance of having been punched, it being as nearly as possible in the form of a circle. - I caused some of the fishing to be removed from the inside, and then found that the space - between the two frames where the hole was situated - had not been cemented when the other part of the ship was done in 1863. - The outline of the hole inside was of an irregular form, and was about 3 ins across at the largest place. - It had every appearance of having been caused by something washing about with the motion of the ship and Bilge-water, until it had actually eaten its way right through the plating. - It was just such a hole, as one could imagine a penny-piece would make, with the motion of the ship assisted by the action of the Bilge-water. - (See Rough-hand Sketch below.)

Section through the Centre of Hole.

The hole above referred to has been well and efficiently repaired. -
