REPORT of SURVEY for REPAIRS.

No. in Reg. Book. **No. 344** Survey held at **Leith** Date **2nd October: 30th Nov^r 1868**
 on the **Iron S.S. "Paris"** Master **Connell**
 Tonnage **408** built at **Glasgow** When built **1865**
 By whom built **Barclay** Owners **D. R. Macgregor & Co.**
 Port belonging to **Leith** Destined Voyage **Baltic**
 If Surveyed Afloat or in Dry Dock **Hot & Dry Docks**

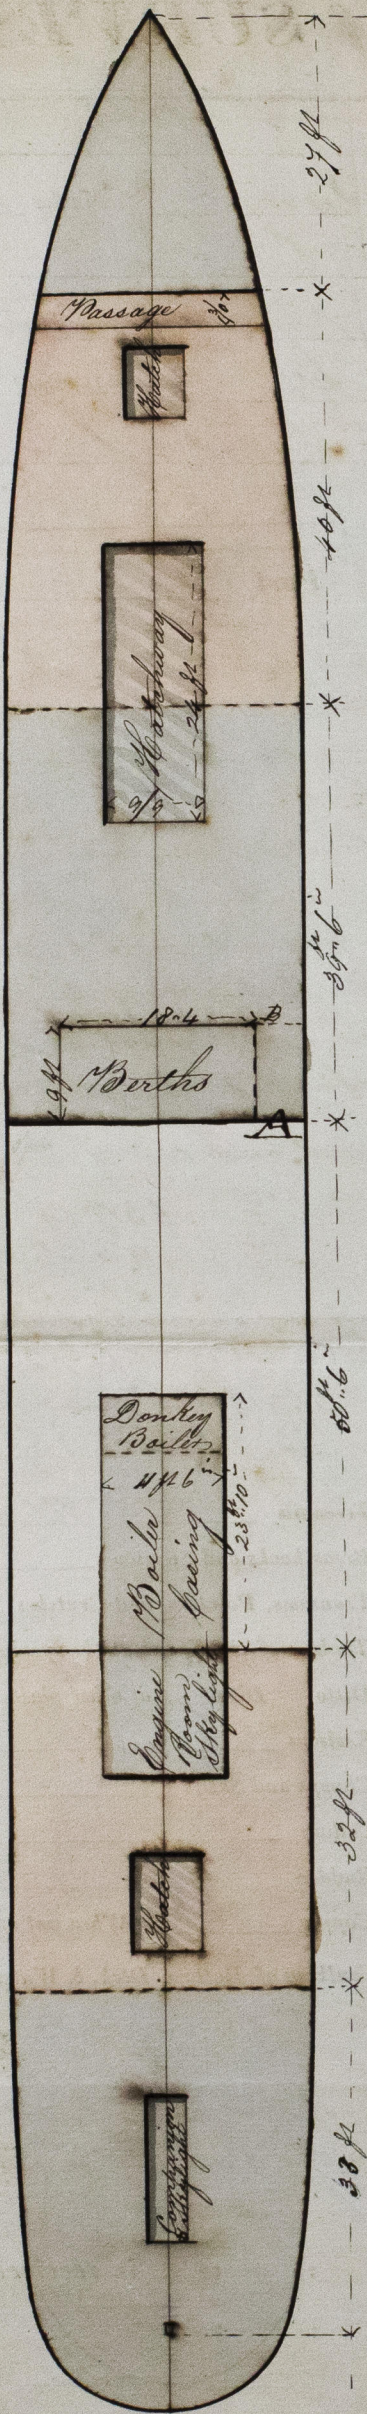
REPAIRS Now done. - This vessel has a Full ^{Top} Hoop, which is now increased in length 32 feet, framed with 4x3x2 Angle Iron at every alternate Frame connected to Hoop Beams formed of 2x4 Angle Iron one 4x3x2 and the other 3x3x2 rivetted back to back; the side ^{Plating} is 3/4 inch in thickness; a fore and aft Tie plate on each side of Hatchways 13x3/8; this lengthened space is used for carrying cargo. The original Bridge has also been extended forward to meet the Full Forecastle so as to form an Awning Deck, framed with single Angle Iron 4x3x2 three feet apart, these frames form the Beams and are carried from side to side down to within six inches of the Main Deck stringer, being rivetted only to the Bulwark plating. The plating above the Bulwark is 3/8 inch thick with plates 12 to 15 feet long; no fore and aft or diagonal Tie plates. Thickness of Deck 3/4 inches. This space now covered in, together with that under the Bridge is also used for carrying cargo. This vessel has been re-measured and the Tonnage is as follows.

Deck Plan showing the present arrangement, the light shade being that now introduced.
