REPORT of SURVEY for REPAIRS.

No. in Reg. Book. **No. 9882** Survey held at Sunderland Date, first Survey 28th Decem^r 1869 Last Survey 25th Februy 1870
 on the Iron Steamer "Dacia" Master G. H. Donnell

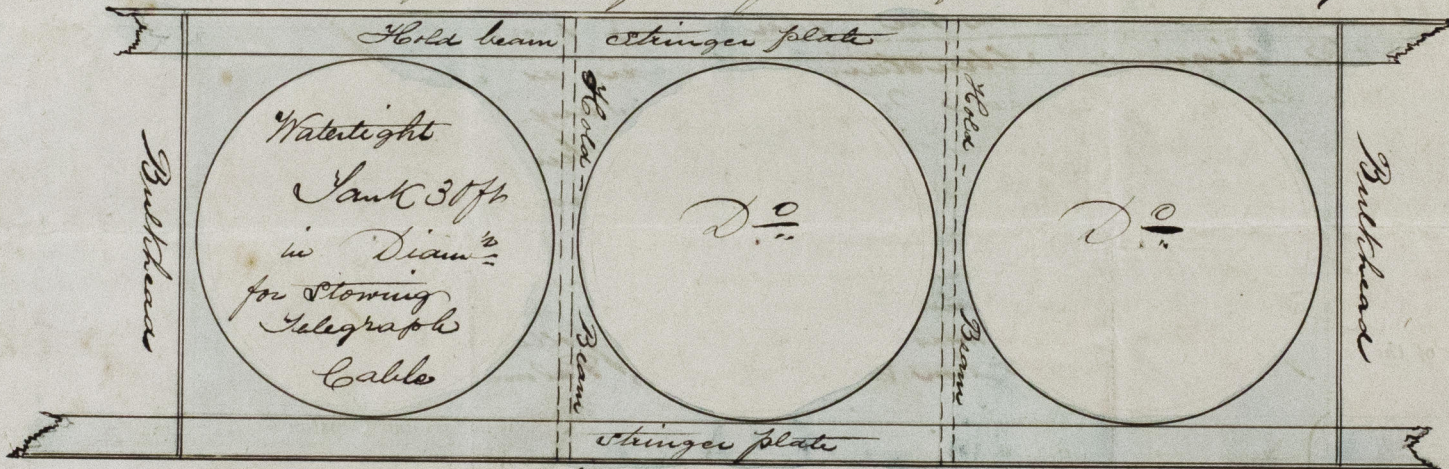
← Plan of Hold from fore to after Bulkhead →

The main hold, from bulkhead to bulkhead, measures over 90 ft in which space there are only two hold beams fitted, see sketch below, and the brackets beneath the hold beam stringers instead of being fitted to alternate frames as per Rule; average about six frames but in lieu of the said beams and brackets there is a complete iron fitted $\frac{5}{16}$ thick, as shown in blue, the object of this arrangement is the carrying of Telegraph Cables in Watertight Circular iron Tanks, the said tanks are bolted down to wood bearers running fore and aft, and side by side, the bearers being first fastened with nut and screw bolts, to alternate frames. The after hold has one Tank only but three beams have now been removed for its introduction, it is fitted in all respects as described above; the Main deck Beams are Pillared in the way of Tanks wherever practicable and is in my opinion efficient, the Rules could not be carried out in this respect without interfering with the paying out of the Cable.

The iron deck here shown ^{in blue} is rivetted to, and rests upon an iron fitted around each Tank.
