REPORT of SURVEY for REPAIRS.

No. in Reg. Book. 94 No. 3253 Survey held at Whitby Date, first Survey 22nd Dec-18 Last Survey 15th Jan'y 1874
on the S.S. "Hector" Master John Minnes
Tonnage 429 built at Sunderland When built 1868
By whom built Lang Owners J. W. Cooper
Port belonging to London Destined Voyage

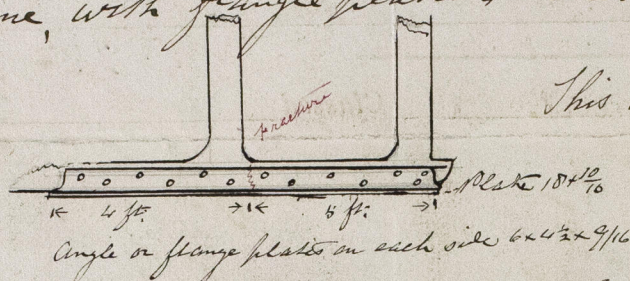
Boiler then a sp. plates fitted as butt straps over these fractures about 10 in. in breadth, the boiler being only 18 in. above top edge of floors, these butt straps have not been efficiently riveted, one flange of lower angle on keelson broken, Propeller post at lower part broken short off at heel now repaired with sole plate underneath $10 \times \frac{10}{16}$ - 9 ft. in length riveted to after keel & lower part of propeller frame, with flange plates on each side $6 \times 4 \frac{1}{2} \times \frac{9}{16}$ the whole length of sole plate.

This arrangement being in my opinion efficient.

The floor plates with bent keel & bottom have not been repaired efficiently or equal to the class of the vessel, the owners were written to with a recommendation that the bent keel should be battened out, the same to be reset & replaced, the floor plates to be double plated over fractured parts, the bottom be got down to its original form & the vessel to be made thoroughly efficient.
