SURVEY REPORT (IRON) 21530 ROSA MARY

REPORT of SURVEY for REPAIRS, &c.

on the **Iron S.S. "Rosa May"** Master **Webster**

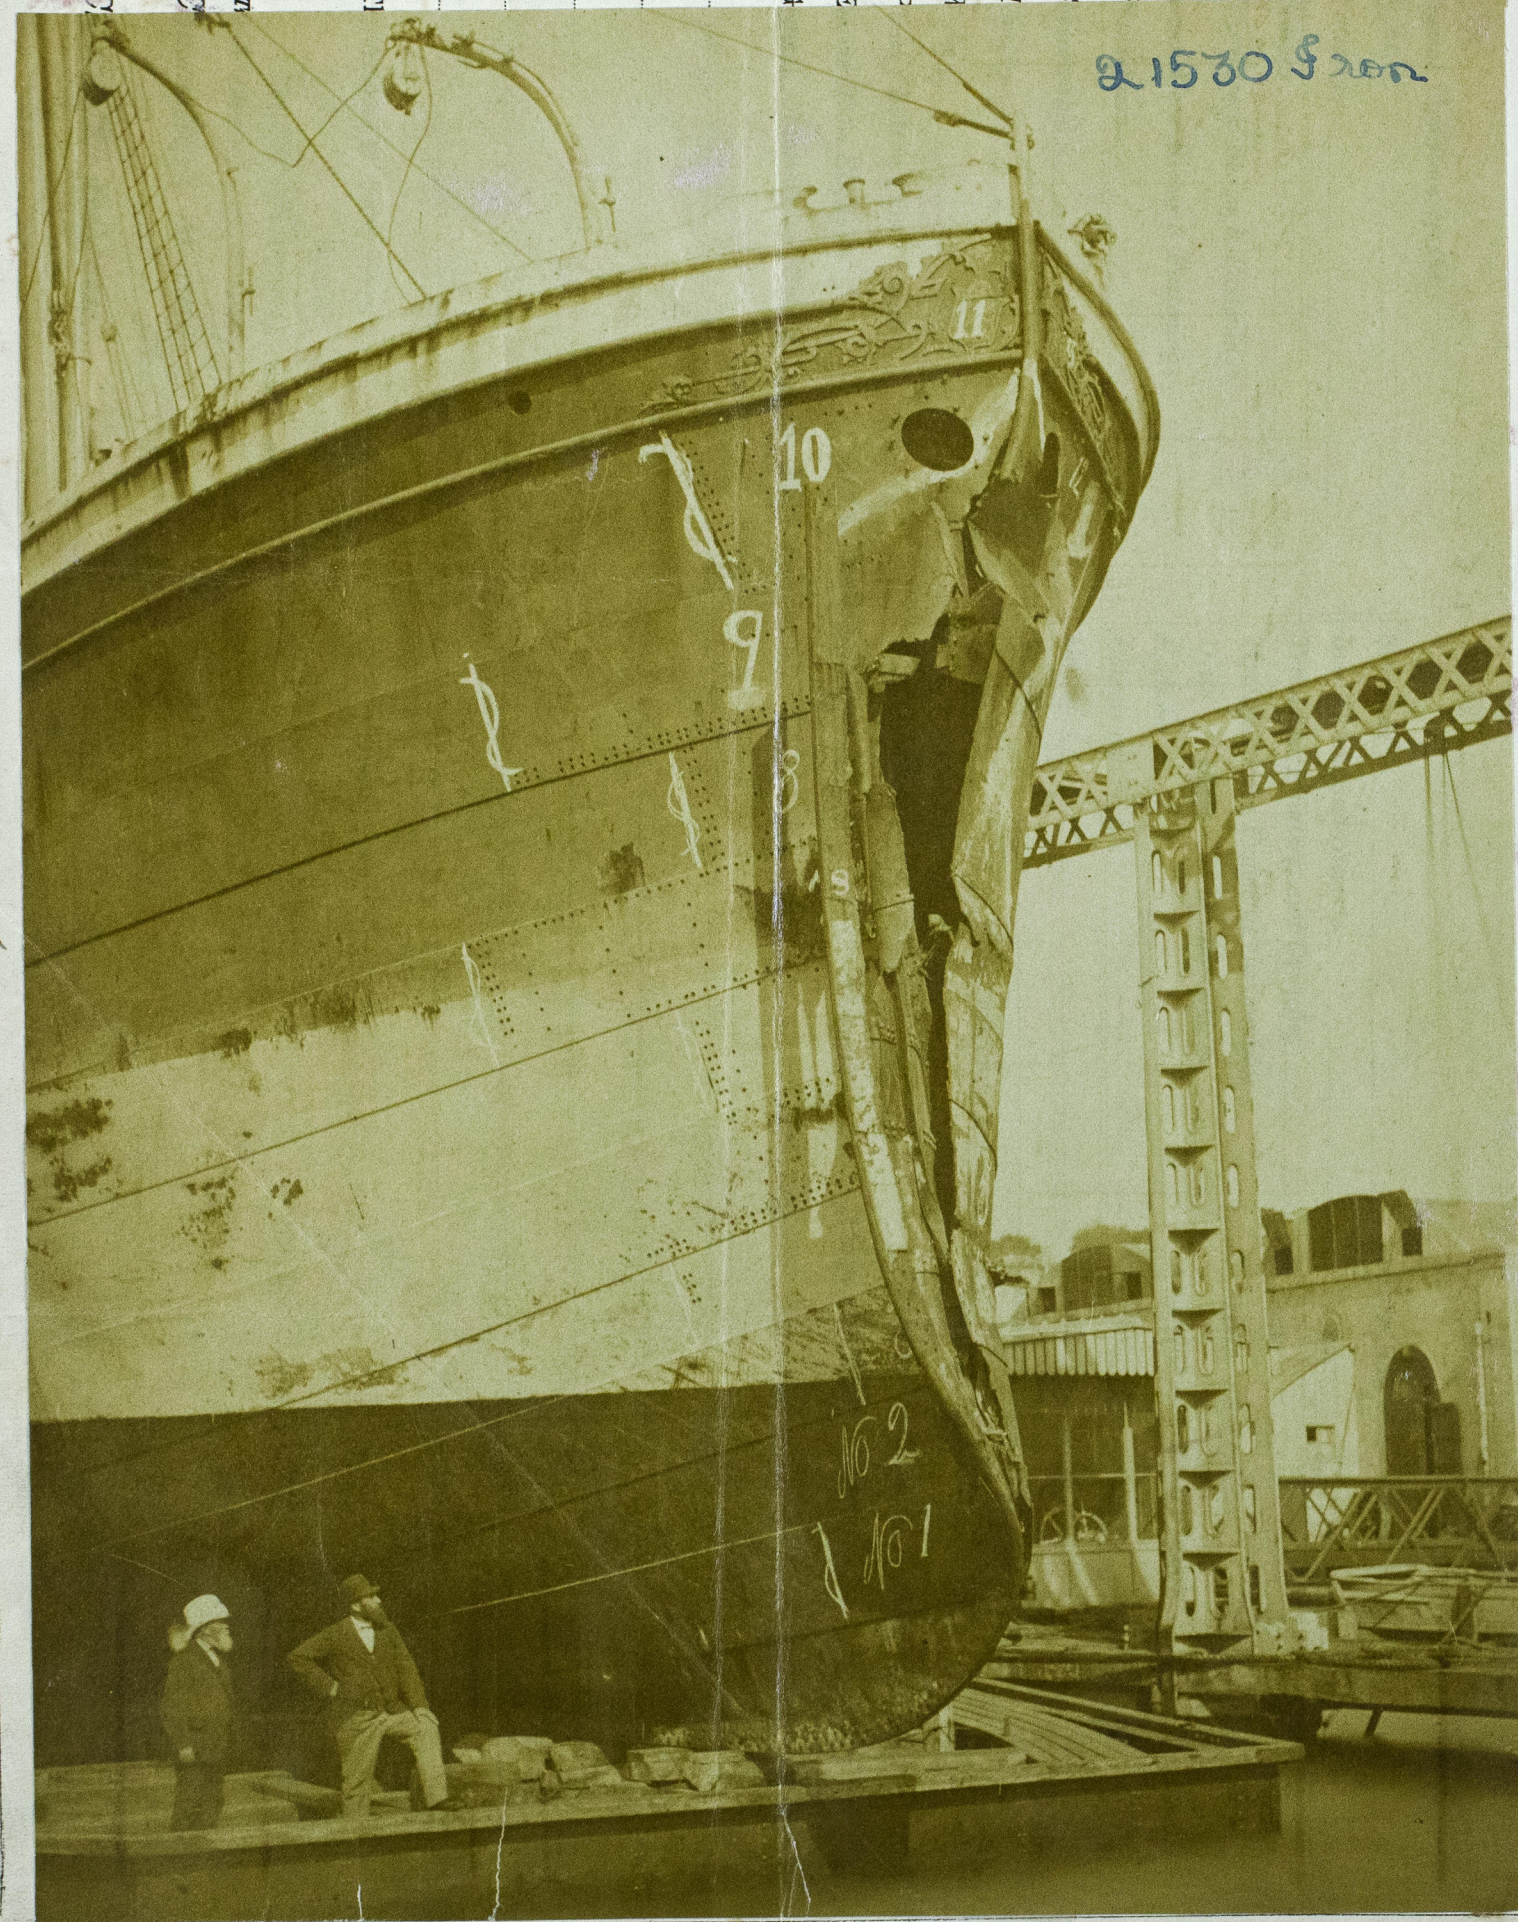
This vessel got on shore in the Red Sea on her voyage out to Bombay, and temporarily repaired there. On her voyage home, she collided with the S.S. "Hampden", which sank, & her own bows were reduced to the state shown in annexed Photographs.

The damages from the Collision, were the Stem, Sundry Frames, Stringers, Plots, & Sundry Frames twisted.

- Stem. The damaged Stem was cut out right down to scarp in keel, & a new Stem fitted, 50ft long in one piece.
- Stem posts. The inner & outer Stem posts were twisted. Inner one from below Stem tube, outer one from close under counter. Several careful heats were made & both posts straightened without fracture.
