# REPORT of SURVEY for REPAIRS, &c.

*Sunderland*

*S.S. "Castello"*

*Damage in consequence of Stranding in Suez Canal also shifting of Cargo.*

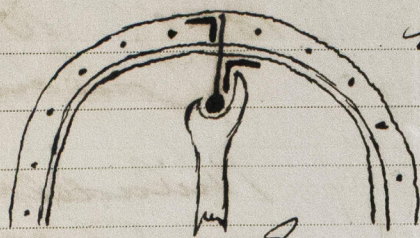
*The keel and Bottom examined; Scraped; Caulked several butts and a few places in the lands each side at the after part of the Vessel: Strengthened the top of the shaft tunnel as follows. Viz. the angle iron frames being nearly all broken at the crown, added a head plate between double frames at about every 4 feet, and brought on the outside of the tunnel from the Mizzen Mast aft, a pair of angles with a hull between so as to receive the Heads of the Stanchions to Main and Hold Deck Beams; and from the Mizzen*

Made forward, a reverse frame is added to each frame at the crown, and a Bulb fitted between two angles, thus, to which were secured pillars that extended to the Tank top, the heels of which are secured to a large single angle in each case, and riveted to the Tank top and middle line fore and aft girder in the Tank.
