Report of Survey for Repairs of Engines and Boilers.

Seaham

1st April / 79

"Harvest Queen"

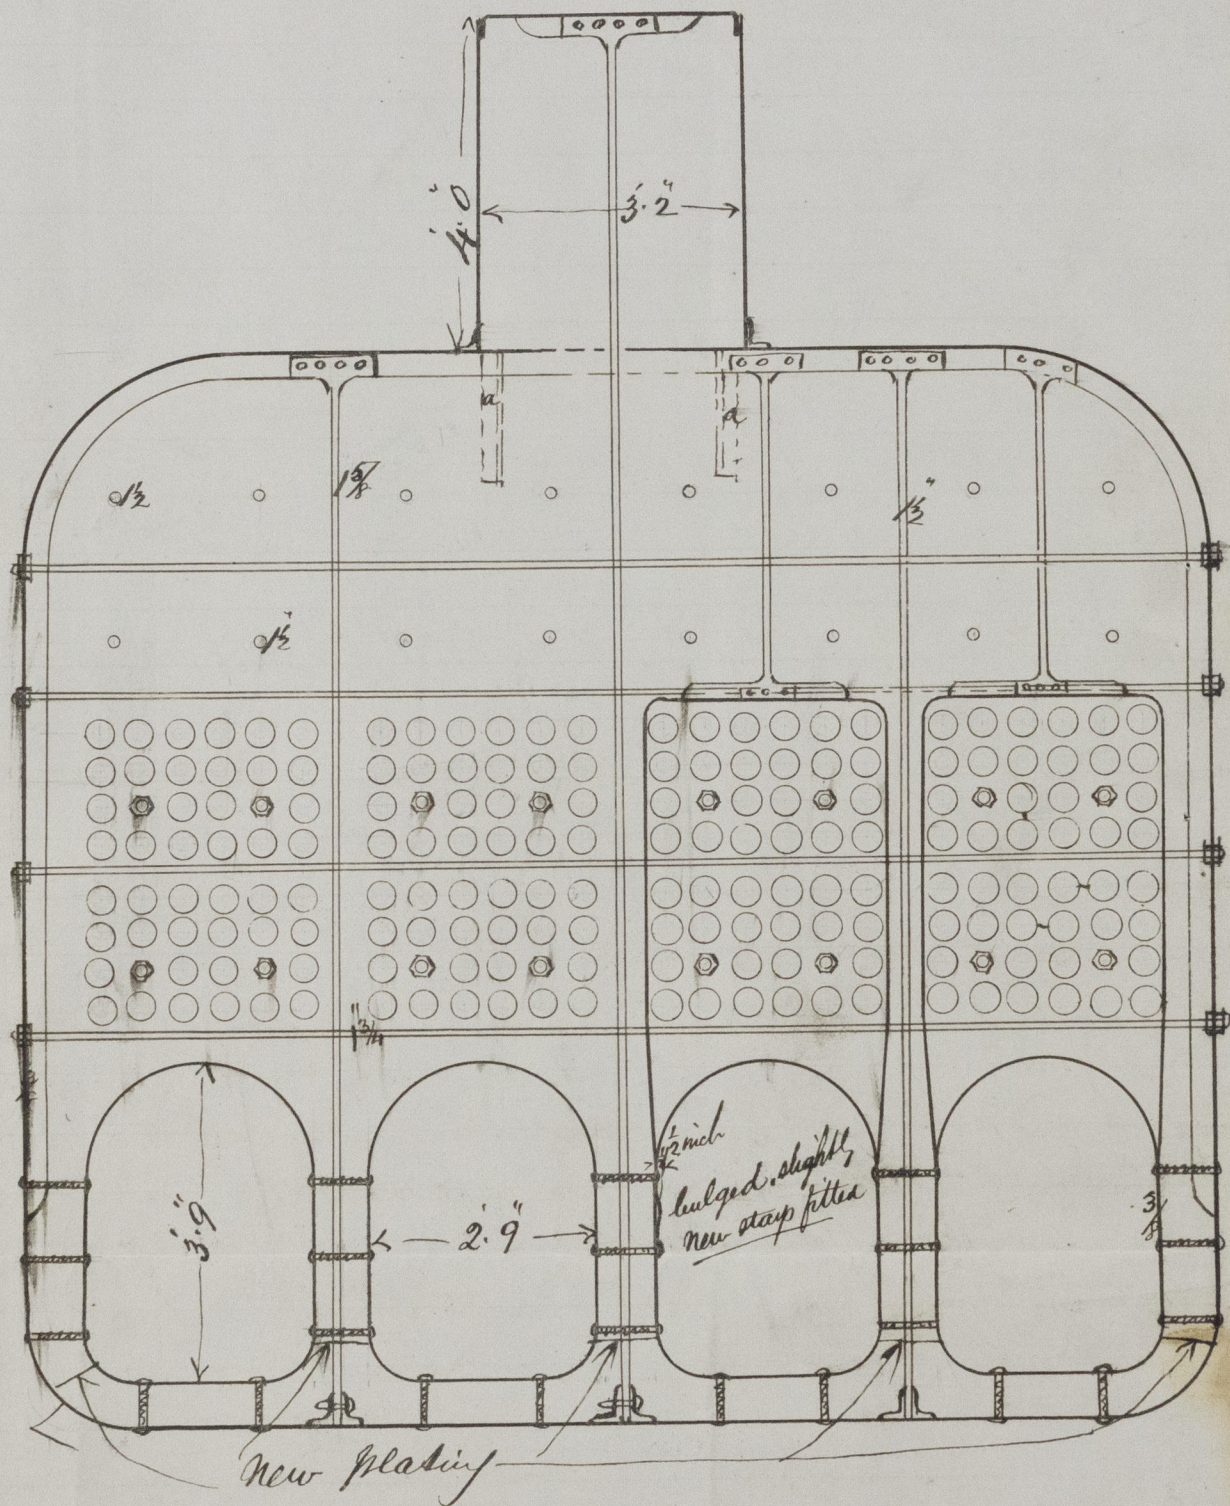
Boiler in the S.S. "Harvest Queen"
May 1879. N.A.

Examined the Main boiler and found seven of the Crown stays very much corroded, the furnace sides slightly bulged in a few places between the screwed stays on the flat side; the back ends of furnaces at top, cracked and patched; the bottom parts of the Combustion chambers were corroded to about $\frac{3}{16}$ of an inch; the back tube plates cracked

a few places between the tubes; a few cracks in the roofs of the Combustion chambers; the joint plates between the bottom of ash pits and bottom of

lev were worn thin, and had been leaking. These defects were made good by fitting 5 extra Crown stays and renewing two of them, new plates riveted top of the furnaces at the back ends, Covering plates put on the Combustion chamber bottoms with the screwed stays through them, new plates fitted all along the joint at bottom of ash pits, and all the other parts repaired as required. The shell was not much corroded, drilled holes through it, at the apparently thinnest parts and found it $\frac{5}{16}$ of an inch thick.

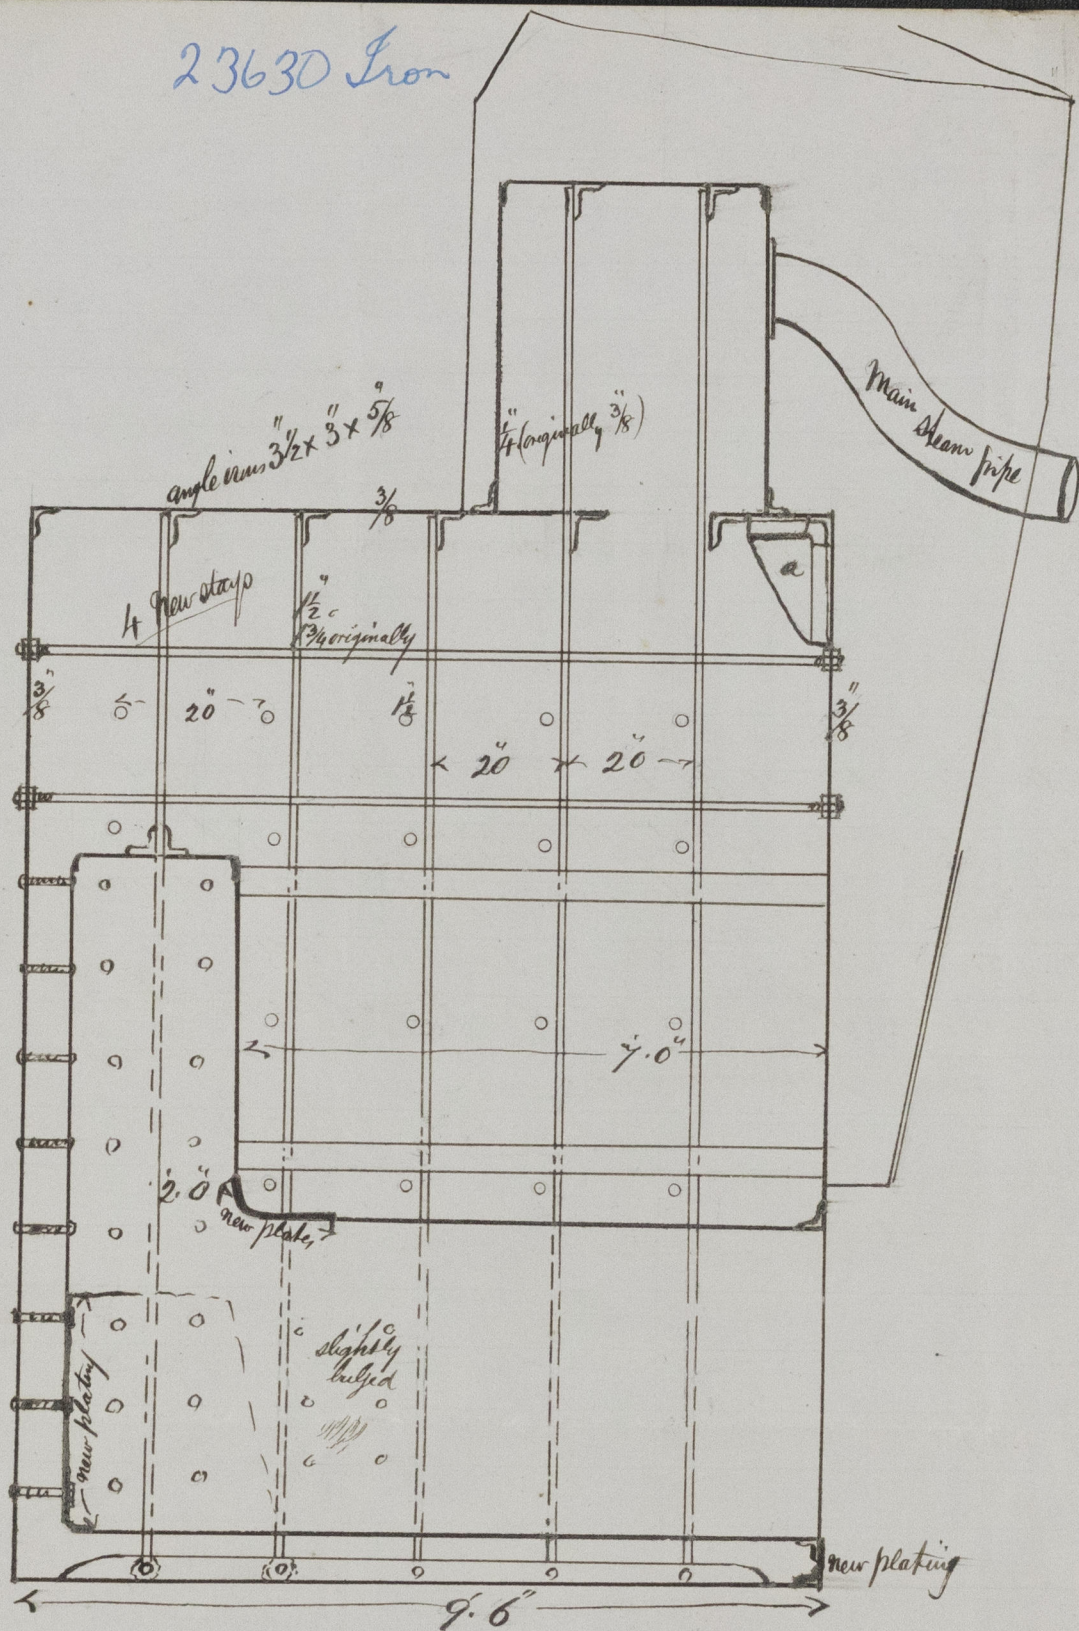
Water space between each furnace, in Combustion chamber
