Report of Survey for Repairs of Engines and Boilers.

Leith

J. Cormack

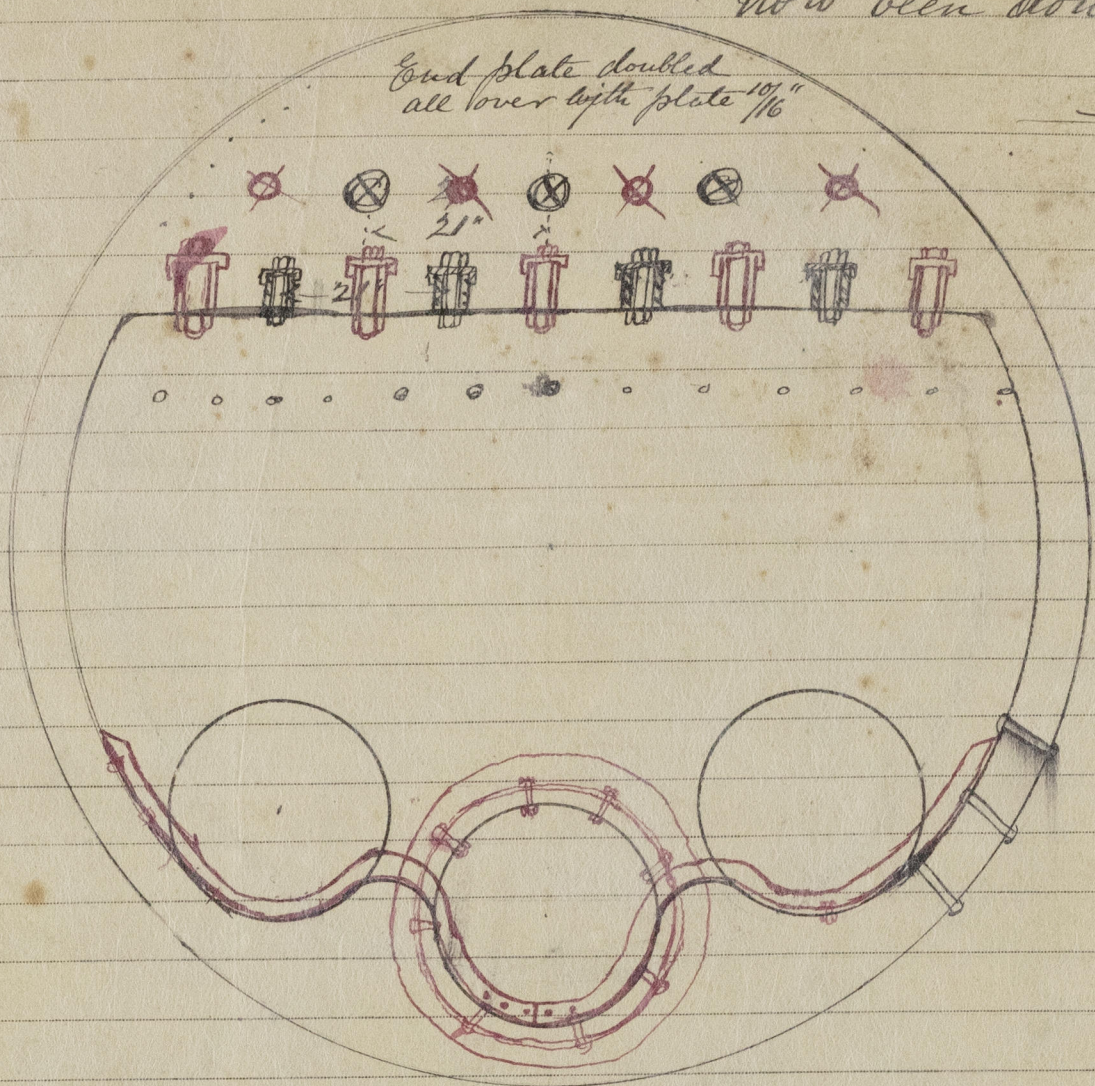
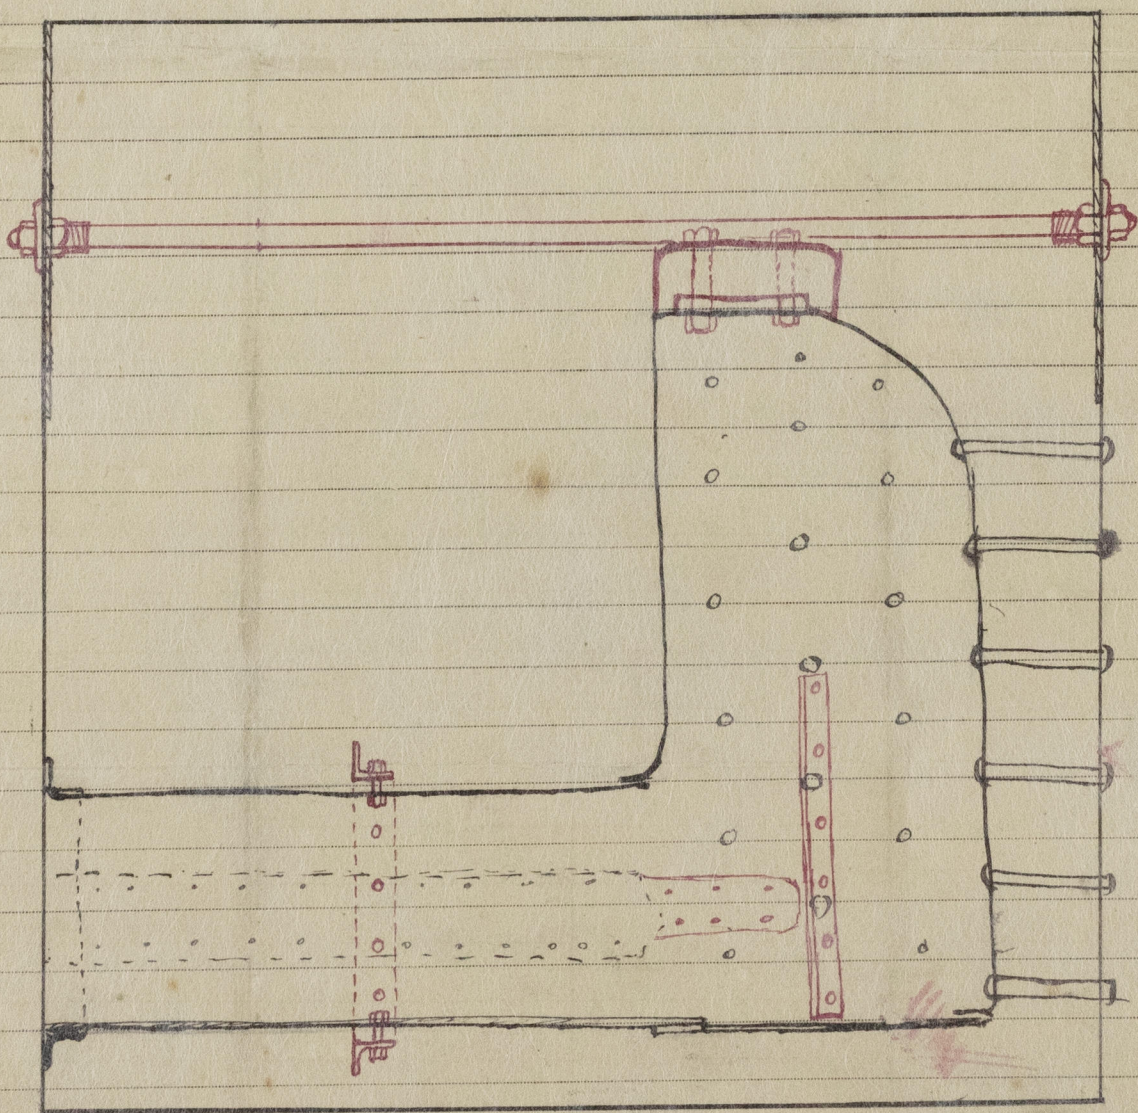
Sketch in red showing what has
now been done

End plate doubled
all over with plate $\frac{10}{16}$ "

The following Repairs, as recommended have not been satisfactorily completed. 1. 6" 4 Longitudinal Stays $1\frac{1}{2}$ " dia. $1\frac{1}{8}$ " ends. fitted with nuts and lock washers, carried through the Steam Space.

5 Guide Stays, with two Studs in each fitted on the Top of Combustion Chambers and the Studs fitted with nuts.

An Angle iron ring fitted on the Centre Furnace.

An Angle iron stiffening bar fitted on the upper side of bottom plating of Combustion Chamber, carried well up to the commencement of screw stays inside. The Combustion Chamber plating is quite straight and the screw stays all in good condition. They having been renewed when the Boiler was last repaired. Several rivets in the ends renewed.
