Report of Survey for Repairs of Engines and Boilers.

No. 26380
 (Received at London Office, 2/8/80)
 No. in Reg. Book. *Malta* Date, first Survey *Jan 18th* Last Survey *Feb. 15th 1880.*
 Supp. 15 on the Machinery of the *Iron S. S. "Clymene"* (Number of Visits *12.*)
 Tonnage, Gross *1509.* Built at *Stockton* When built *1879*
 Ditto, Net *974* Owners *A. Cloake & Co* Port belonging to *London*
 Diameter of Cylinder *32" & 60"* Engines made by *Blair & Co. "him"* When made *1879.*
 Length of Stroke *39"* Boilers made by *do* When made *1879.*
 Pressure of Steam *82 lbs* If Surveyed Afloat or in Dry Dock *Afloat & Dock Pontoon* Years assigned *100. A 1*
 Registered Horse Power *140* Classed *7. 79.*
 Last Survey No. *Stockton*

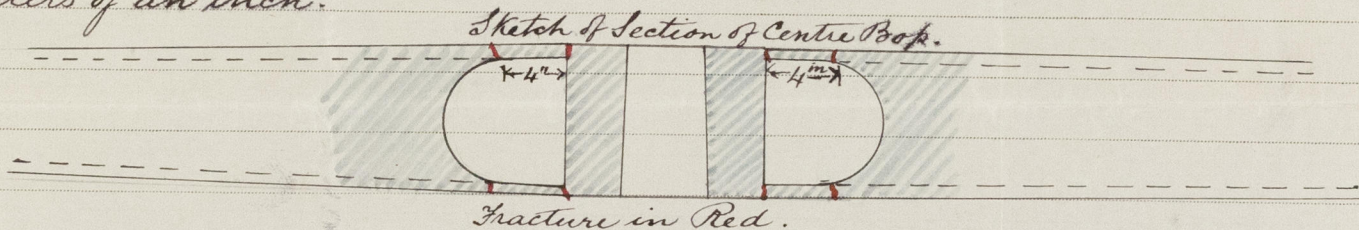
Particulars of Repairs and Examination *This vessel came into port in a nearly disabled condition on Sunday, Jan 18th, on examination of the machinery I found the low pressure piston broken & lying at the bottom of cylinder & cylinder cracked for several feet round the flange, on a subsequent occasion I examined the piston, then lying up on deck, I found that the centre bop into which piston rod fits had torn out of the body of the piston, carrying away a ring of the metal of the top & bottom sides, there being no further connection between this bop & outer part of piston except by these sides, the internal ribs, not running into centre bop by about 4 inches, the thickness of metal of top & bottom is barely three quarters of an inch.*

I had no opportunity of examining the interior of new piston supplied from England by the makers of the Engines, as the Captain of vessel objected to taking out core plug or tampering with piston in any way, as he was afraid it might result in a lawsuit, & he argued that the old piston had passed all surveys & had stood the work for about six months, so that all that could be done was to put the new piston to as severe a proof as possible under steam, by letting in full steam from auxiliary starting valve, which was done on the trial run from dock to new harbour. The interior of cylinders both High & Low Pressure are also in a very unsatisfactory condition, for a nearly new ship. The high pressure cylinder is much scored, and low pressure cylinder oval, P.T.O. it has -

General Observations, Opinion, and Recommendation:— *This vessel has been rendered fit for the voyage home, but on her arrival in England it will be necessary to make the permanent repairs to rudder & Stern Post, and it would be advisable that machinery be overhauled.*
