REPORT of SURVEY for REPAIRS.

No. 203 Survey held at London Date Sept 26th Oct 1857
 on the Ship Sea Star Master Livingston
 Tonnage 654 Built at Aberdeen When built 1853
 By whom built _____ Owners Livingston
 Port belonging to Glasgow Destined Voyage _____
 If Surveyed Afloat or in Dry Dock Brodie's dry dock

Last Survey, No. 1053 Port Aberdeen Classed G A 1.

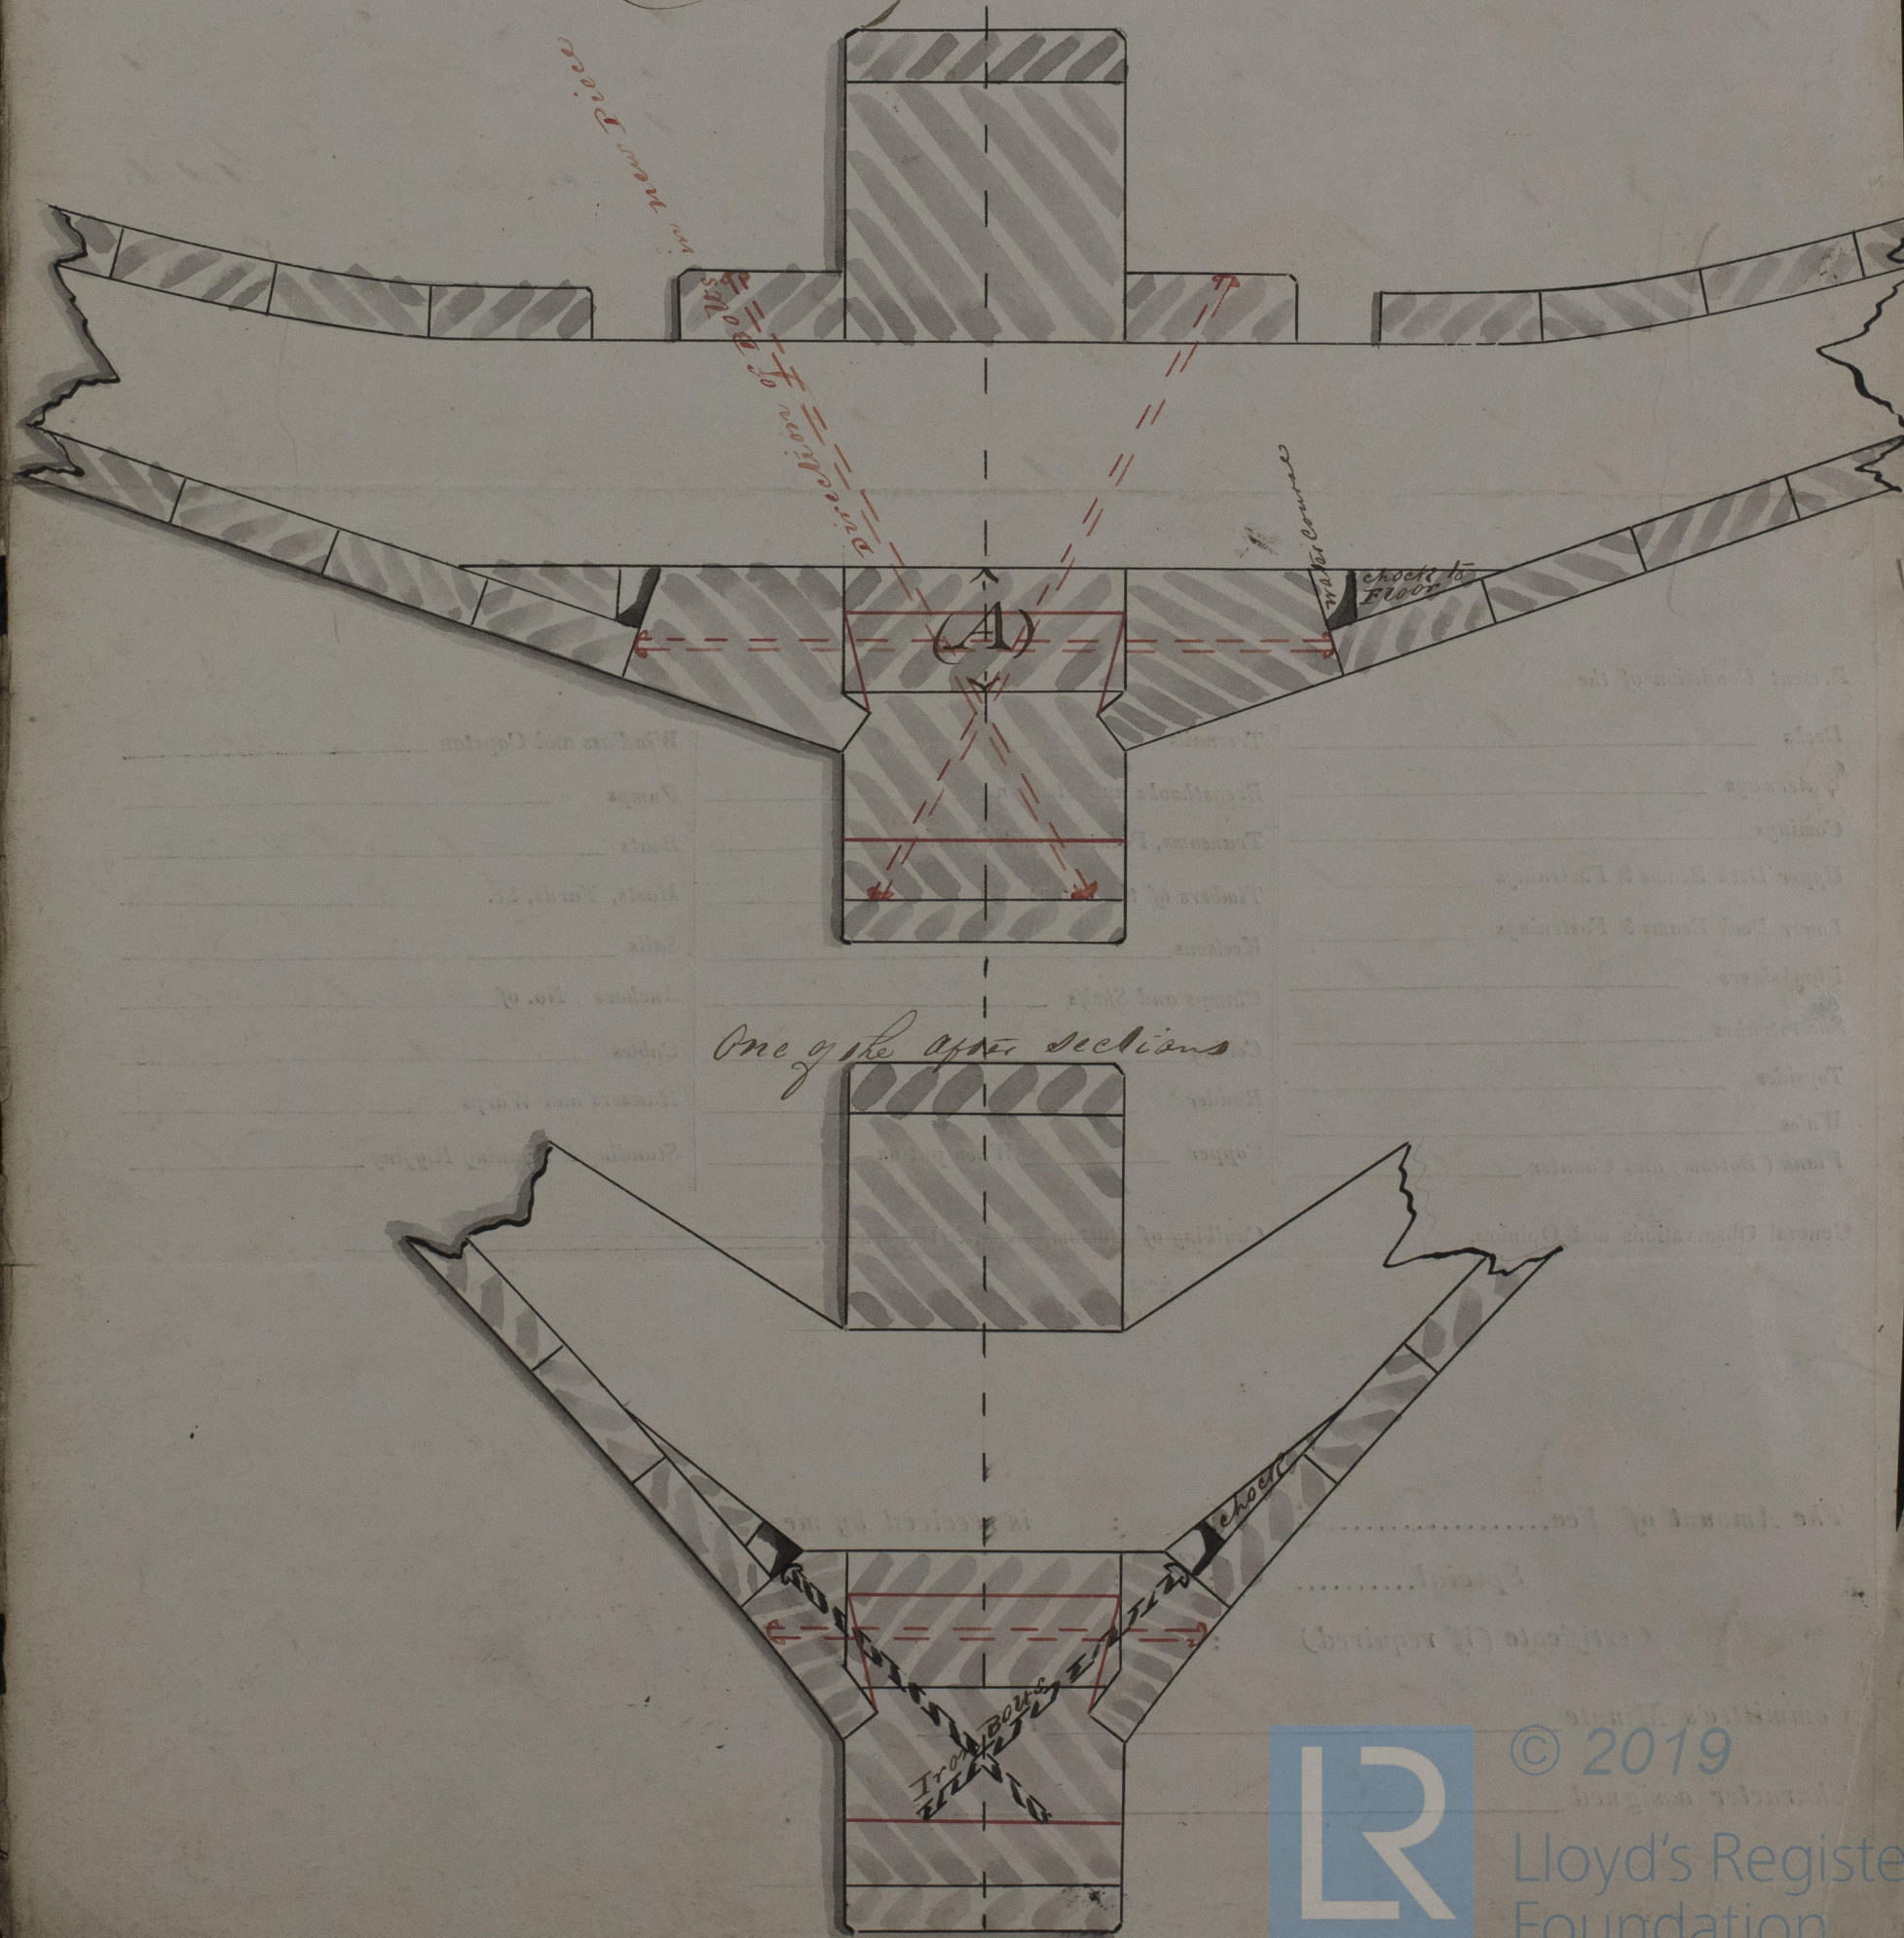
Midships Section

REPAIRS of damage now done (For particulars see Special Rep^t)
 The second piece from aft of main-heel renewed of American Oak without removing the thick garboards, and metal bolted through each floor that had not the Nelson-bolts at first (Vessel fitted with double floors) the original bolts being cut off and clenched on the under side of the piece marked (A) in the sketch on the opposite side; additional bolts are also driven diagonally through the lumber-strakes in way of the same as marked in red to support the main-heel which was found to be fitted with scarcely any back rabbet and the bolting of thick garboards of iron as shown in an upper section where it could be seen; vessel hung in shores, the copper sheathing stripped to above the turn of bilges, the vessel caulked in way of the same and the copper renewed, ^{fore and aft pieces of false keel}
 All the garboards and strakes of this vessel are not fitted to side of main-heel, but to inner heel, or deadwood fore and aft.

whereby their efficiency becomes considerably less than would be if properly fitted with a sufficiency of back-rubber to main heel, and deep enough to receive cross-bolting as shown in Red. We beg to call the Committee's early attention to the same with a view to discouraging a mode of fitting which in our opinion does not accord with the requirements expressed in foot-note to (Table B)
