REPORT of SURVEY for REPAIRS, &c.

108 on the Iron Scw. Stm. Fr. "De Bay."

If Surveyed Afloat or in Dry Dock In Dry Dock Name of Dock Deptford Green. Destined Voyage

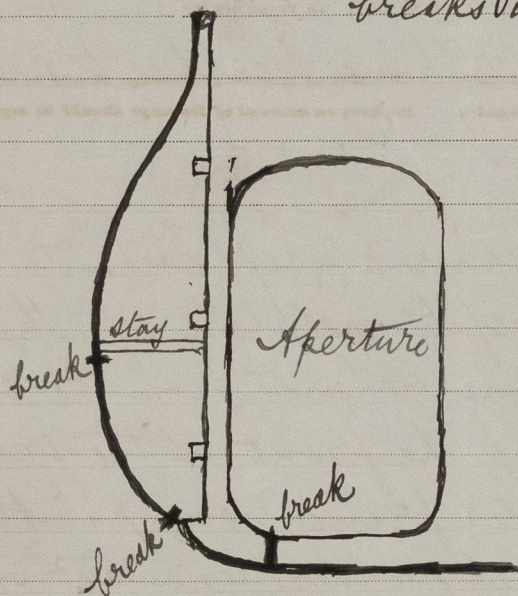
Plan of lower part of stern frame.

Damage repair stated to have been due to grounding also special survey N^o 1 held again by Owners' desire.

Sketch showing break in stern frame & two }
breaks in rudder frame }

Damage repair. The stern frame taken out, repaired & replaced - to do which it was found necessary to take out and refit one plate of the garboard strake. The back of the rudder frame renewed from the stay downwards, including a piece of about 3 feet up the front of the frame and the lowest pintle. The front of the rudder frame & one pintle straightened. The lower plate on each side of rudder renewed. About 2 feet of the lower part of rudder trunk, also deck gland of rudder renewed. The bottom of vessel examined and repainted - part of the painting due to damage.

The rudder pintles bushed. About 4 feet of the after part of the hoaxter plate on each side of vessel renewed.* A plate $\frac{1}{2}$ inch thick worked each side at upper part of the aperture & extends to 18 inches below arch of the stern frame.
