# REPORT of SURVEY for REPAIRS, &c.

Survey held at London

24<sup>th</sup> Feb<sup>y</sup> 1887

371 on the Iron S.W. Steamer "Pickwick".

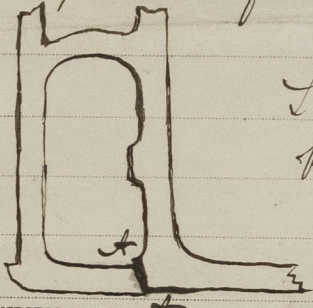
Damage repair-stated to have been due to grounding. The stern frame taken out, repaired and refitted. The <sup>rudder</sup> stern tube renewed. Part of one plate of the counter on port side renewed. A short length of the double angle iron bilge keel on the port side renewed. The bottom of vessel repainted (part only due to damage). An anchor supplied in place of the stream anchor, the marks seen on this anchor are 8-3-21 which in all probability indicate the weight, but no marks could clearly be seen to show that the anchor is a properly tested anchor. Wrote to the Owner in reference to the same but no reply has been received.

Sketch showing break (A.A) in the stern frame now repaired efficiently.
