REPORT of SURVEY for REPAIRS, &c.

on the *Iron Steamer "Ananda" (contd)*

475 ^{Don} Sketch showing borings of the outside plating. S.S. "Ananda"
Starboard Side.

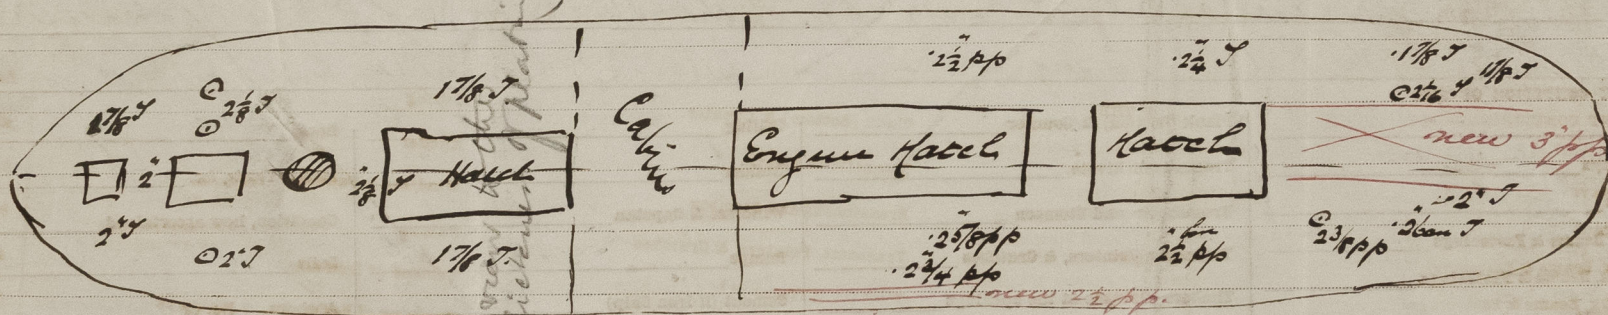
Sketch showing Thickness of deck.

I. another oak plank p.p. pitch pine.

The rules required when the vessel was built $3\frac{1}{2}$ " pitch pine or 3" Oak. but $2\frac{1}{2}$ " Oak was allowed to be fitted for first entry Report. The owners have been recommended to renew or double this deck. The doubling to be at least 2" thick p.pine.
