REPORT of SURVEY for REPAIRS, &c.

No. 188 Port of London
Survey held at London Date, First Survey 6th Dec 87 Last Survey 14th Feb 1888
No. in g. Book. 376 on the Iron Steamer "Sir Robert Peel" Master J. W. Harlock.
TONNAGE:— NET 238 Built at Middlesbro' By whom R. Craggs & Sons. When 1885
GROSS 376 Owners E. F. Carey Port belonging to London.
UNDER DK. 281 Owner's Address (if not already recorded in Appendix to Register Book.)
If Surveyed Afloat or in Dry Dock In Dry Dock Name of Dock Fountain Destined Voyage (Dunkirk).
Length of Poop ft.: of Forecastle ft.: of Raised Or. Deck ft.: Moulded Depth ft. ins.
(if these particulars are not yet recorded in the Register Book.)
Classed 100 A. 1.
Last Survey, No. 47485 Port London
(State clearly the cause of Repairs if any, and, in detail, the nature and extent of Examinations and subsequent Repairs. Society's Freeboard (if assigned) in Summer ft. ins.
Repairs on account of Damage should be separated from Repairs due to other causes. State also the dates and Initials as painted on Ship in Winter ft. ins.

REPAIRS, OR EXAMINATION AS PER RULE, FOR Repair of damage

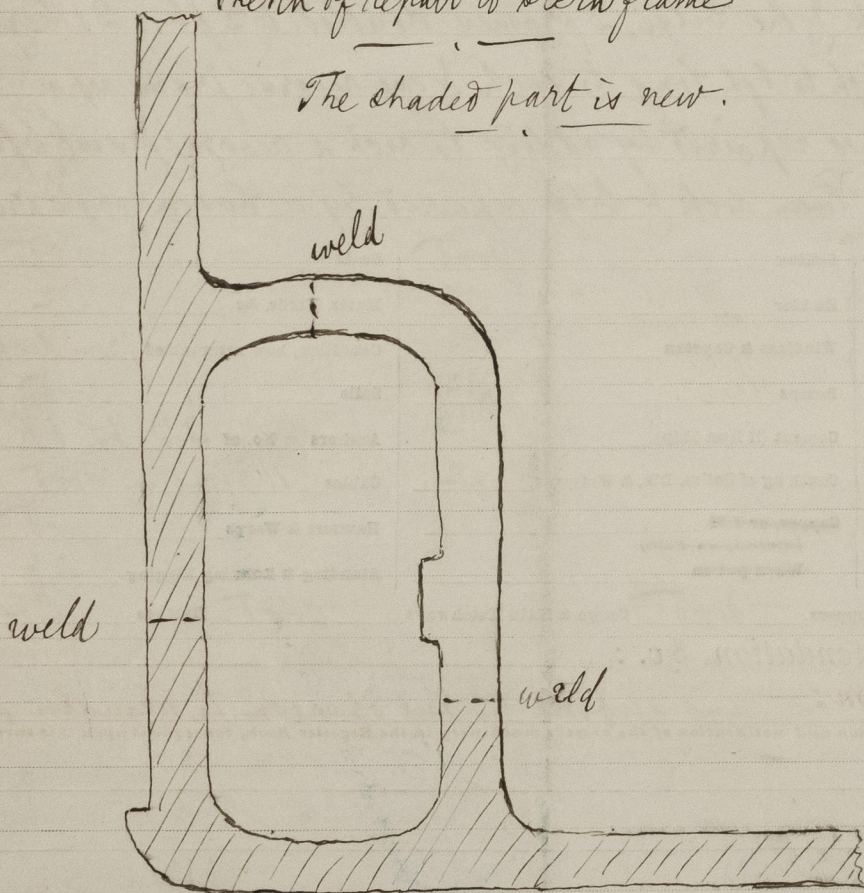
Sketch of repair to stern frame

The shaded part is new.

All the close ceiling in the holds & bunkers removed. The cabin fittings & fittings in the fore-castle removed. The chain cables removed from the locker - ranged & found complete. The stern frame taken out & the greater part renewed - the same refitted. The rudder renewed. One plate of garboard strake taken out (in way of scarp of stern frame with keel) on starboard side - the same re-riveted. One short frame right aft renewed on each side. One boss plate on starboard side renewed. One plate of (B) strake in after hold starboard side & one plate of (B) strake port side in fore hold taken out - to remove the dirt; these plates re-riveted. Two butt straps of (B) strake renewed viz. one on port side & one on starboard side. 4 frames at port bilge & 2 frames at starboard bilge repaired by bosom angle irons. 3 long vertical angle iron stiffeners & 2 short ones at after engine room bulkhead out, straightened & re-riveted. In the fore hold on port side between the deck & the bilge, 2 frames doubled 6 1/2 ft. 2 other frames repaired by adding a reverse frame 6 ft. to 8 ft. long to each & one reverse frame repaired by a strap. On the starboard side 2 frames repaired by adding to each a reverse frame 6 ft. long. One frame in after hold on port side tween deck & bilge repaired by a bosom angle iron.
