# REPORT of SURVEY for REPAIRS, &c.

REPAIRS, OR EXAMINATION AS PER RULE, FOR Damage S. S. Lon Not-88  
Sustained in consequence of laying aground at  
Fennings Wharf London Bridge March 2<sup>nd</sup> 1889.

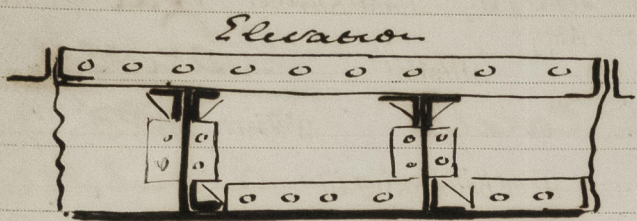
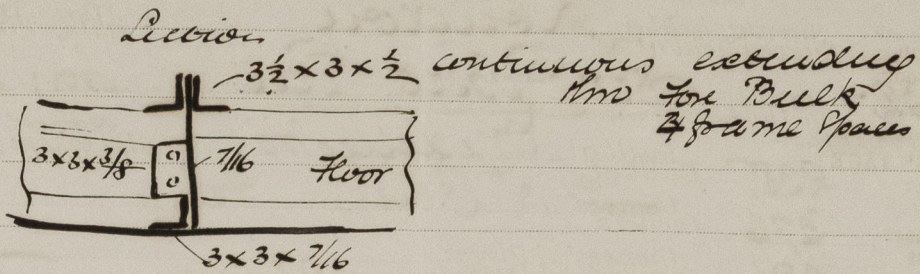
as shown in rough sketch below.

and a 3 inch pillar fitted at middle from Pulley to Strong Beam dividing Engine & Boiler space & a 2 1/2 inch pillar each side of this extending from the new intercooler Reelion to same beam.

The vessel was placed in dry dock, the vessel amidships hung in Pulge Blocks and shores. Ten feet of keel rivets renewed and one Starboard Garboard butt under fore end Machinery re-riveted, & Keel and Garboard seams caulked where requisite.  
 The coal Bunkers cleared out and ceiling lifted, the Boiler hold and Engine Room flat removed & the Pulge timbers, floors, frames, cleaned & carefully examined. Several loose rivets renewed in Engine Bearers.  
 The cement removed in several bays & an intercostal keelson fitted between Engine Room Bulhead over

The cement made good where removed; ceiling Stoke Hold & Engine Room feet made good. etc
