# REPORT of SURVEY for REPAIRS, &c.

No. 70 Date of Writing Report May 28<sup>th</sup> 1889 Port of London  
 No. in Reg. Book. 70 Survey held at London Date, First Survey May 7<sup>th</sup> Last Survey May 27<sup>th</sup> 1889  
 on the Iron Sailing Ship: "ZEALANDIA" Master J. Phillips

REPAIRS, OR EXAMINATION AS PER RULE, FOR a portion of the Special Survey (3<sup>rd</sup>) No. 3 (not final)  
This vessel was surveyed whilst dry, on blocks, in Mr. Green's  
and Co's Graving Dock, Blackwall, and subsequently whilst afloat  
in the East End Dock.

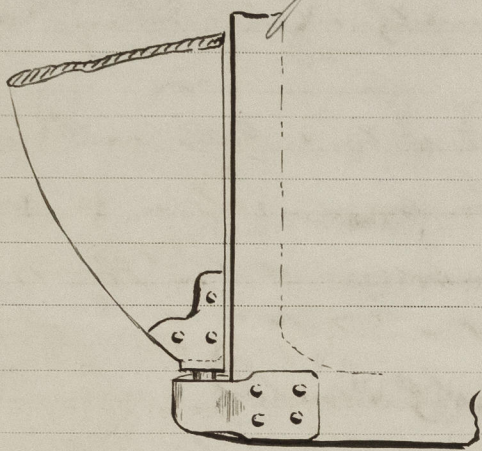
Externally, the vessel was found in first class order and <sup>was</sup> scraped and re-coated. The Cuddles were lifted for the examination of the joints, the lower one of which was renewed, and at the bottom gudgeon was found considerably worn on one side an iron strap was fitted to it as shown below and the new joint was made to line with the others.
