REPORT of SURVEY for REPAIRS, &c.

REPAIRS, OR EXAMINATION AS PER RULE, FOR S.S. No 3 (Completion)

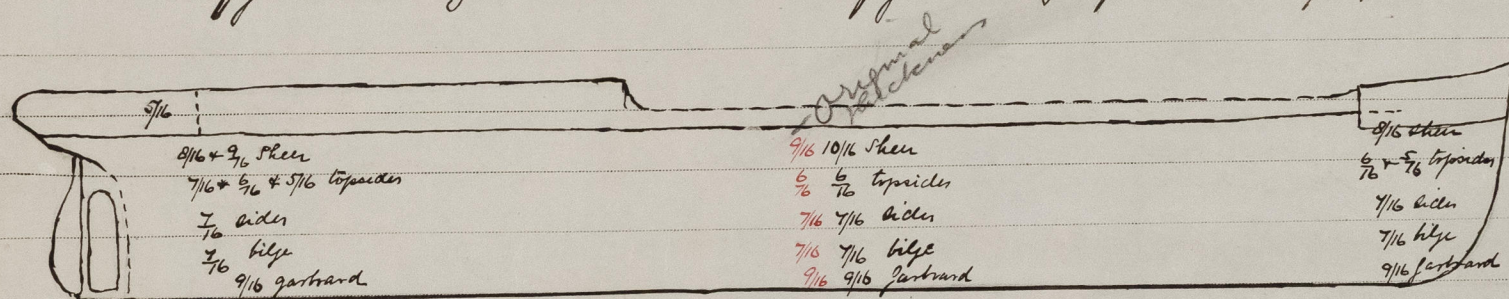
The shell plating has been drilled where required so as, with the drilling noted on the London report referred to, to amount to one hole in each strake of plating on each side of the vessel at three sections viz. amidships, in the after body and before the peak bulkhead. A sketch is made below in which are

Given the measurements at these places & in aid with the thicknesses given in the original, or first entry, report. From a comparison of these thicknesses it will be seen that the diminution in the plating is but slight. Renewal of several plates has now been made not on account of reduced thickness but on account of indentation sustained through contact with piers or quay walls in entering or leaving the various ports to which the vessel has headed, or from grounding under circumstances of which no record is given. These plates are as follows. 3. One plate - for two - on the starboard bow & one plate on the port bow, in the 7 strake; one plate in flat of bottom, in main hold & bunkers in the D strake. In way of the fore gangways, where the strake bent below the sheer strake was indented, in lieu of removing these plates they have been faired in place & then doubled for two plate lengths. In other places where the indents have been slight & unimportant the plates have been faired in place. In way of the renewed bow plates several pieces of frame & reverse bar have been cut out & renewed, or doubled.

Black figures show sizes where drilled - Red figures sizes from 1st Survey report.
