# REPORT of SURVEY for REPAIRS, &c.

No. *5* Date of Writing Report *February 15<sup>th</sup> 1890* Port of *London*  
 No. in Reg. Book. *1* Survey held at *London* Date, First Survey *Jan 28<sup>th</sup>* Last Survey *Feb 13<sup>th</sup> 1890*  
 on the *Steel Screw Steamer* "NAIRNSHIRE" Master *P. Wallace*

REPAIRS, OR EXAMINATION AS PER RULE, FOR *for the purpose of replacing a Bower Anchor and some chain cables reported to have been lost (See Dunedin Report dated Nov. 30<sup>th</sup> 1889 and numbered 111)*

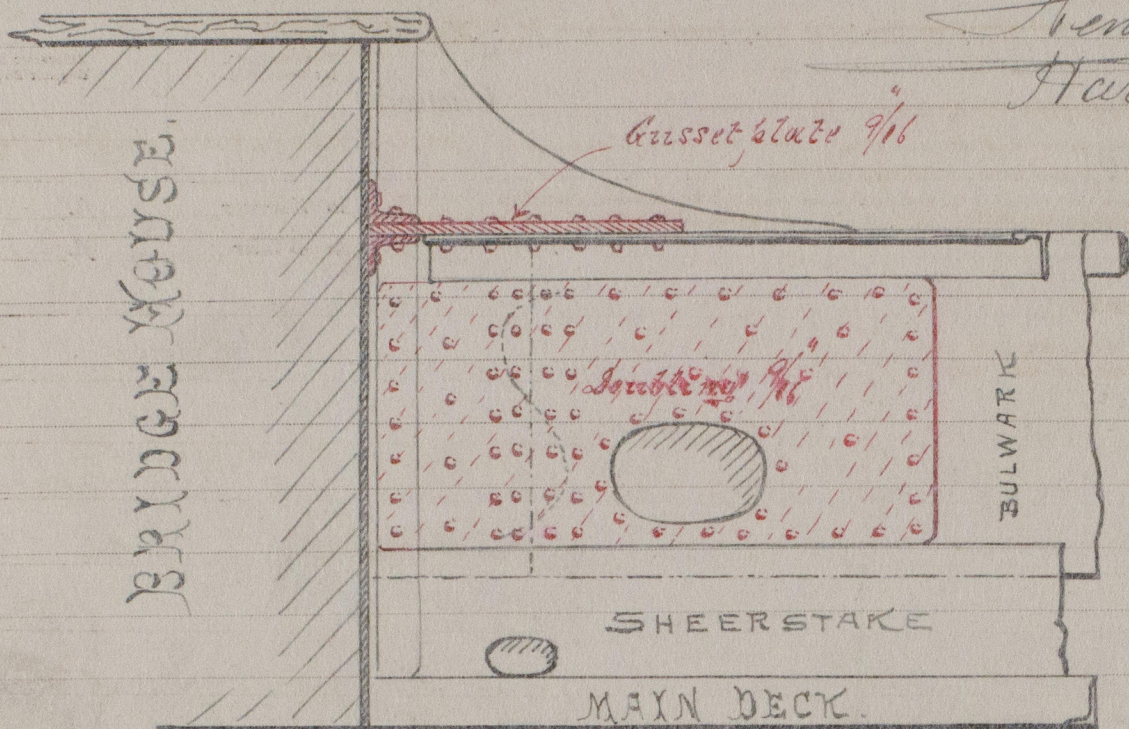
*In addition to the above, the vessel was placed in Dry Dock; the Bottom was cleaned and re-painted; the Butts of the bulwark plates, on each side, at the front of the midship bridge, which showed signs of working*

were disconnected and a doubler plate about 4'6" long by  $\frac{9}{16}$ " thick was fitted at that point and joggled over the BH vertical bar at side, a substantial knee plate of the same thickness was also fitted horizontally over the iron main rail and connected by a double bar to the iron B.H. at Bridge point, as shown on sketch below.
