REPORT of SURVEY for REPAIRS, &c.

No. 748 Date of Writing Report 17-6-90 18 Port of London
 No. in Survey held at London Date, First Survey 6-5-90 Last Survey 14-6-1890
 Reg. Book. 1326 on the SOUKAR Iron S Master Reeson
 (No. of Visits 23)

REPAIRS, OR EXAMINATION AS PER RULE, FOR Special Survey No 3

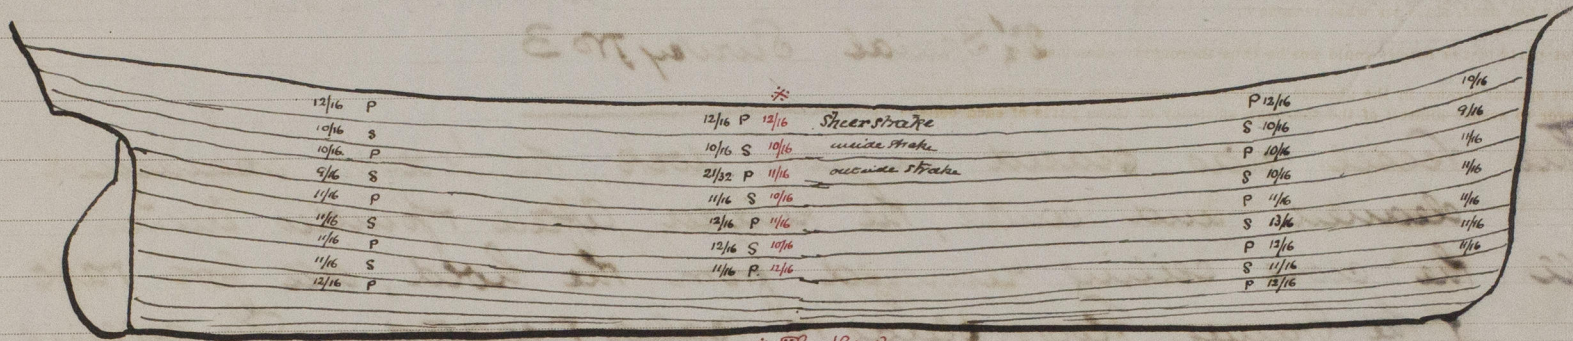
Rough sketch showing drilled holes
for measuring thickness.

The shell plating was drilled in 3 Sections as prescribed by the Rules and the thicknesses are given on the rough sketch on opposite side of this report.

* The thickness in Red
 are as stated on the First Entry Report.

P. holes drilled on port side
 S. " " " " " " " " " " " "
