REPORT of SURVEY for REPAIRS, &c.

on the Dharwar Iron Bk Master Hatchings YEAR. 62 MONTH. 80

REPAIRS, OR EXAMINATION AS PER RULE, FOR Special Survey No 3.

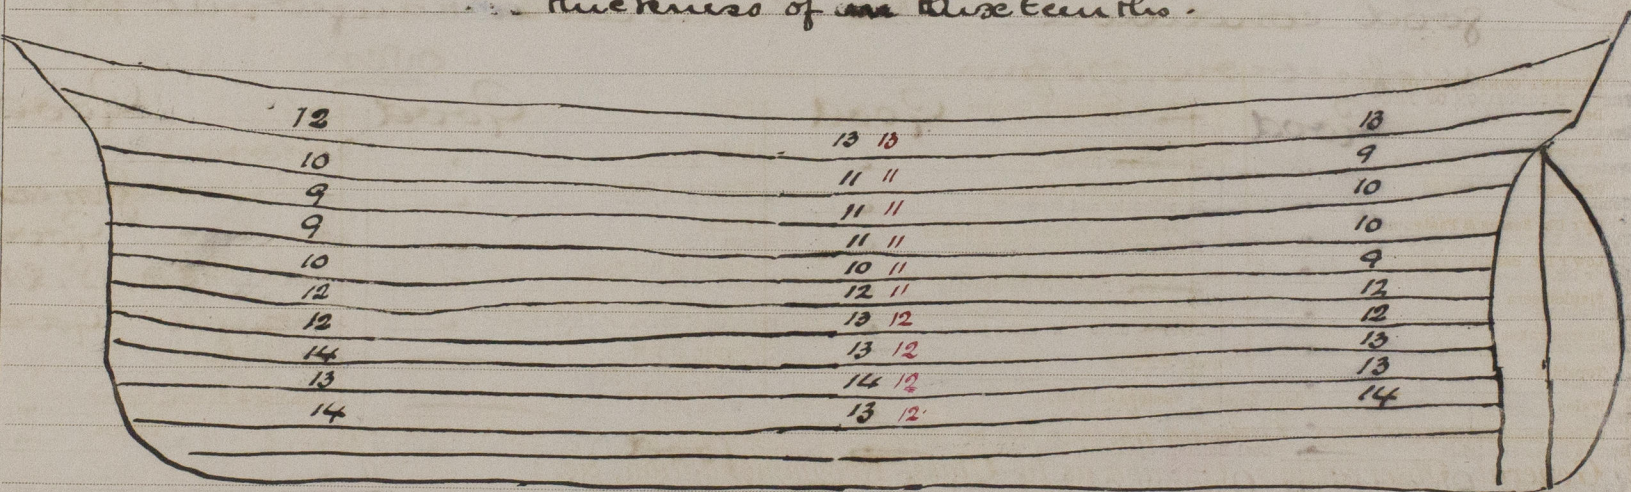
Rough sketch of thickness of outside plating
thickness of ~~the~~ sixteenth.

The hoops and peaks cleared, all close ceiling removed and all oxidation removed from floors frames, stringers and plating. The plating under side lights exposed and repaired by doubling under same as stated below. The shell plating has been drilled in three vertical lines forward, aft and amidships as shown in rough sketch on opposite side of this report.

Thicknesses in red as per first survey report.
