REPORT of SURVEY for REPAIRS, &c.

460 on the *Iron Ship "Persian Empire"* Master *C. Hay 89-89*
 TONNAGE:— Built at *West Hartlepool* By whom *Pile, Spence & Co* When *1865* MONTH *9th*
 NET *1532* Owners *G. Duncan & Co* Port belonging to *London*
 GROSS *1532* Owner's Address
 UNDER DK. *1457* (if not already recorded in Appendix to Register Book.)

REPAIRS, OR EXAMINATION AS PER RULE, FOR *Part special survey N^o 3.*

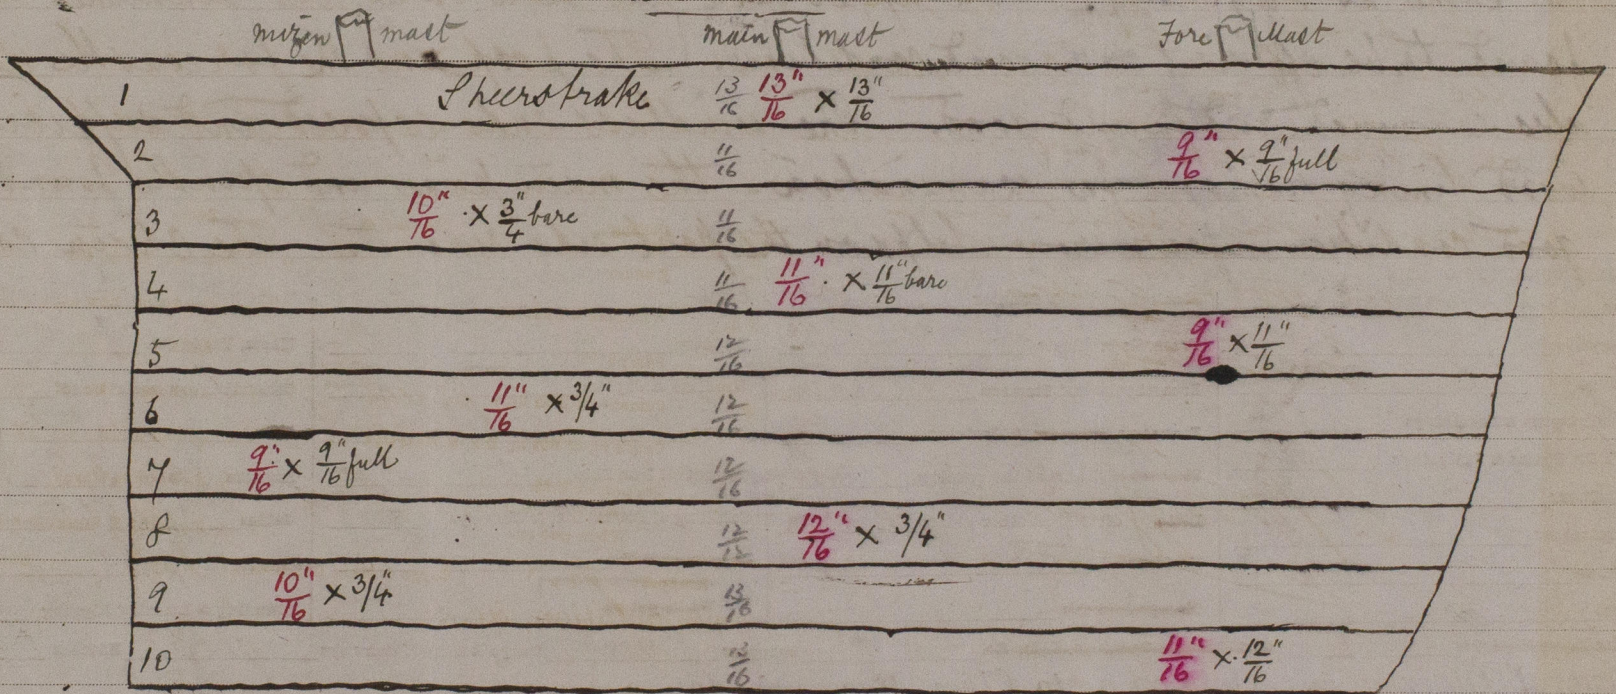
Starboard Side

Sketches showing where shell plating has been drilled
Thicknesses in red are original thicknesses
Do in black are present. Do
