REPORT of SURVEY for REPAIRS, &c.

Survey held at London

788 on the Steel Screw Steamer "Star of Victoria" Master John Smyth

REPAIRS, OR EXAMINATION AS PER RULE, FOR Condition & Alterations.

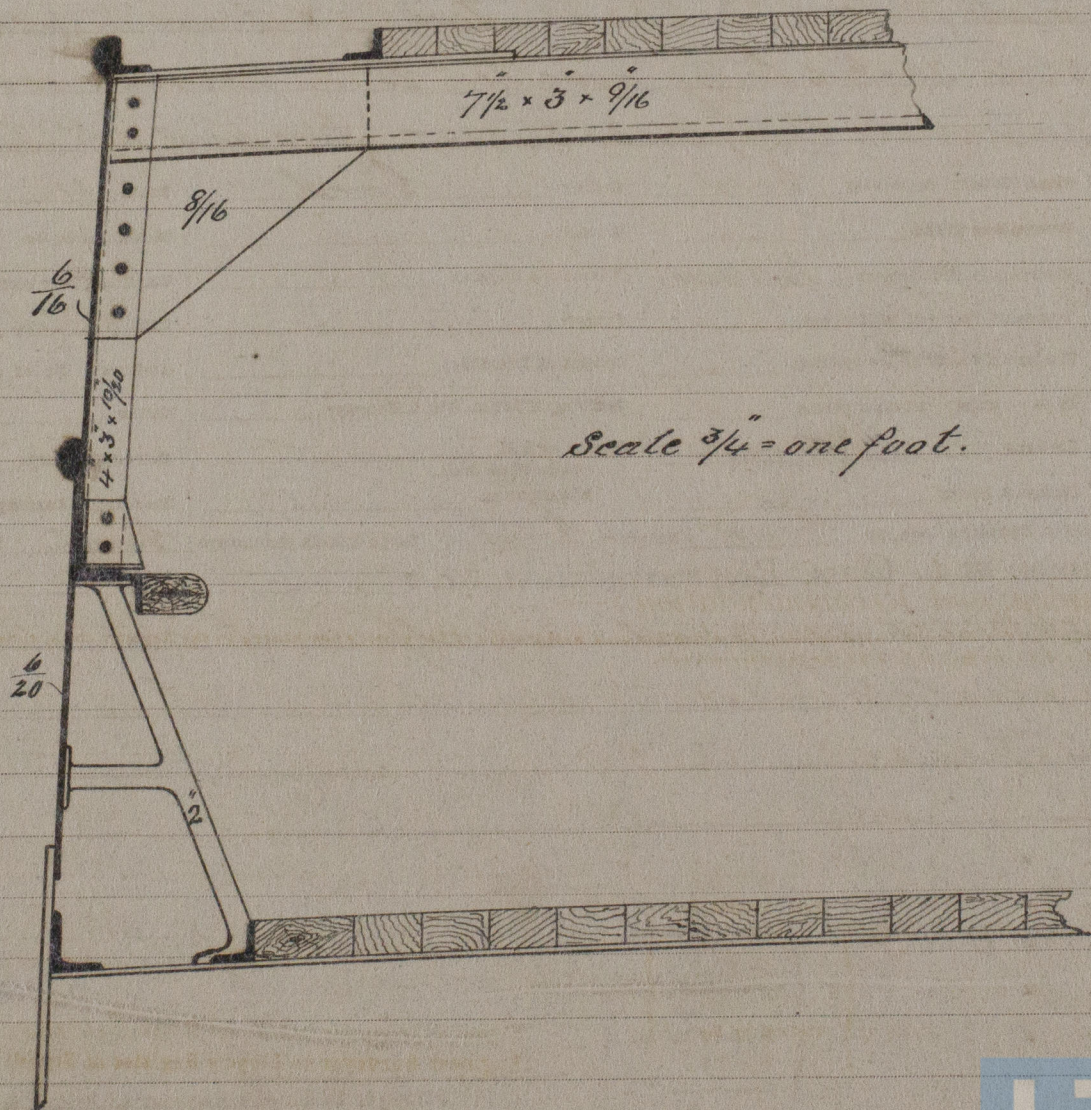
The Top Gallant Forecastle has now been extended aft for a distance of 58 feet, and built on to the top of the original Bulwark plating, and connected thereto by vertical frames consisting of Steel Angles 4 x 3 x 1/2 spaced about 4 feet apart stepped on to the wood Main Rail and connected thereto, by small angle lugs 6 x 3 1/2 x 1/2 and to the Bulwark plating by three rivets. The sides plated with 1/16 Steel plates double rivetted at butts and lapped on to the inside of the Bulwark plating.

A bulkhead has been built across the after end, consisting of steel plating $\frac{5}{16}$ thick, craming plate $15 \times \frac{9}{16}$ with angle $5 \times 3\frac{1}{2} \times \frac{9}{16}$ secured to the upper deck by square headed screw bolts, through the wood deck and tapped into the steel deck plating underneath, the bulkhead being supported on the inside in the centre, by five vertical web plates 5 feet in width & $\frac{9}{16}$ thick about 3 feet apart, extending from deck to deck, their edges being stiffened with angles $4 \times 3 \times \frac{7}{16}$. The sides being supported by two vertical ^{Bulb} angles $7\frac{1}{2} \times 3\frac{1}{2} \times \frac{9}{16}$ (one on each side of doorway) and two vertical angles $7 \times 3 \times \frac{9}{16}$ between the latter and the side of vessel.

The following sketch shows the manner in which the structure has been connected to the Bulwarks. -
