REPORT of SURVEY for REPAIRS, &c.

on the Iron S. British Peer Master

TONNAGE: NET 1428 GROSS 1478 UNDER DEK. 1372 Built at Belfast By whom Harland & Wolff When 1865

REPAIRS, OR EXAMINATION AS PER RULE, FOR S.S. No 3 + Damage Repairs

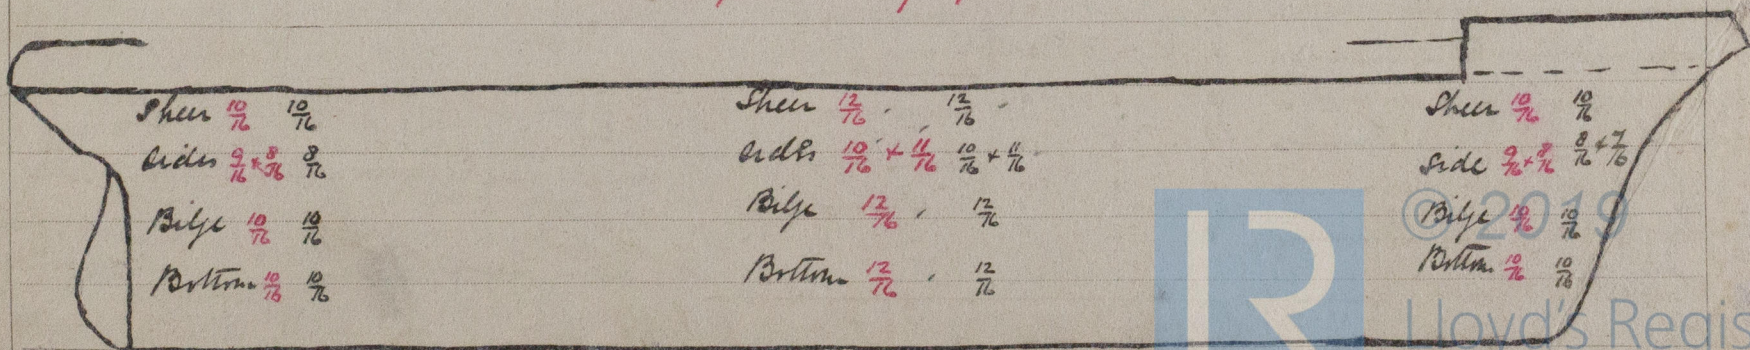
Black as drilled
Red as per 1st Entry Report

In connection with the 6th Survey required by the Rules for the Liverpool Registry. All the requirements for this survey have been fully carried out, every stake of plating being drilled in three positions viz at the bow, amidships, & at the after end.

As stated above the result of these drillings is to show that there is but little diminution from the original scantlings.
