REPORT of SURVEY for REPAIRS, &c.

No. in Reg. Book. *198* Survey held at *London* on the *Iron ship "Sandringham"* Date, First Survey *10 Aug* Last Survey *27 Oct* 1891
(No. of Visits) Master *Fernbach*

REPAIRS, OR EXAMINATION AS PER RULE, FOR *Damage & 6th Survey*
This vessel is stated to have grounded at *Savannah La Mar* near *Jamaica* on *July 4th 1891*

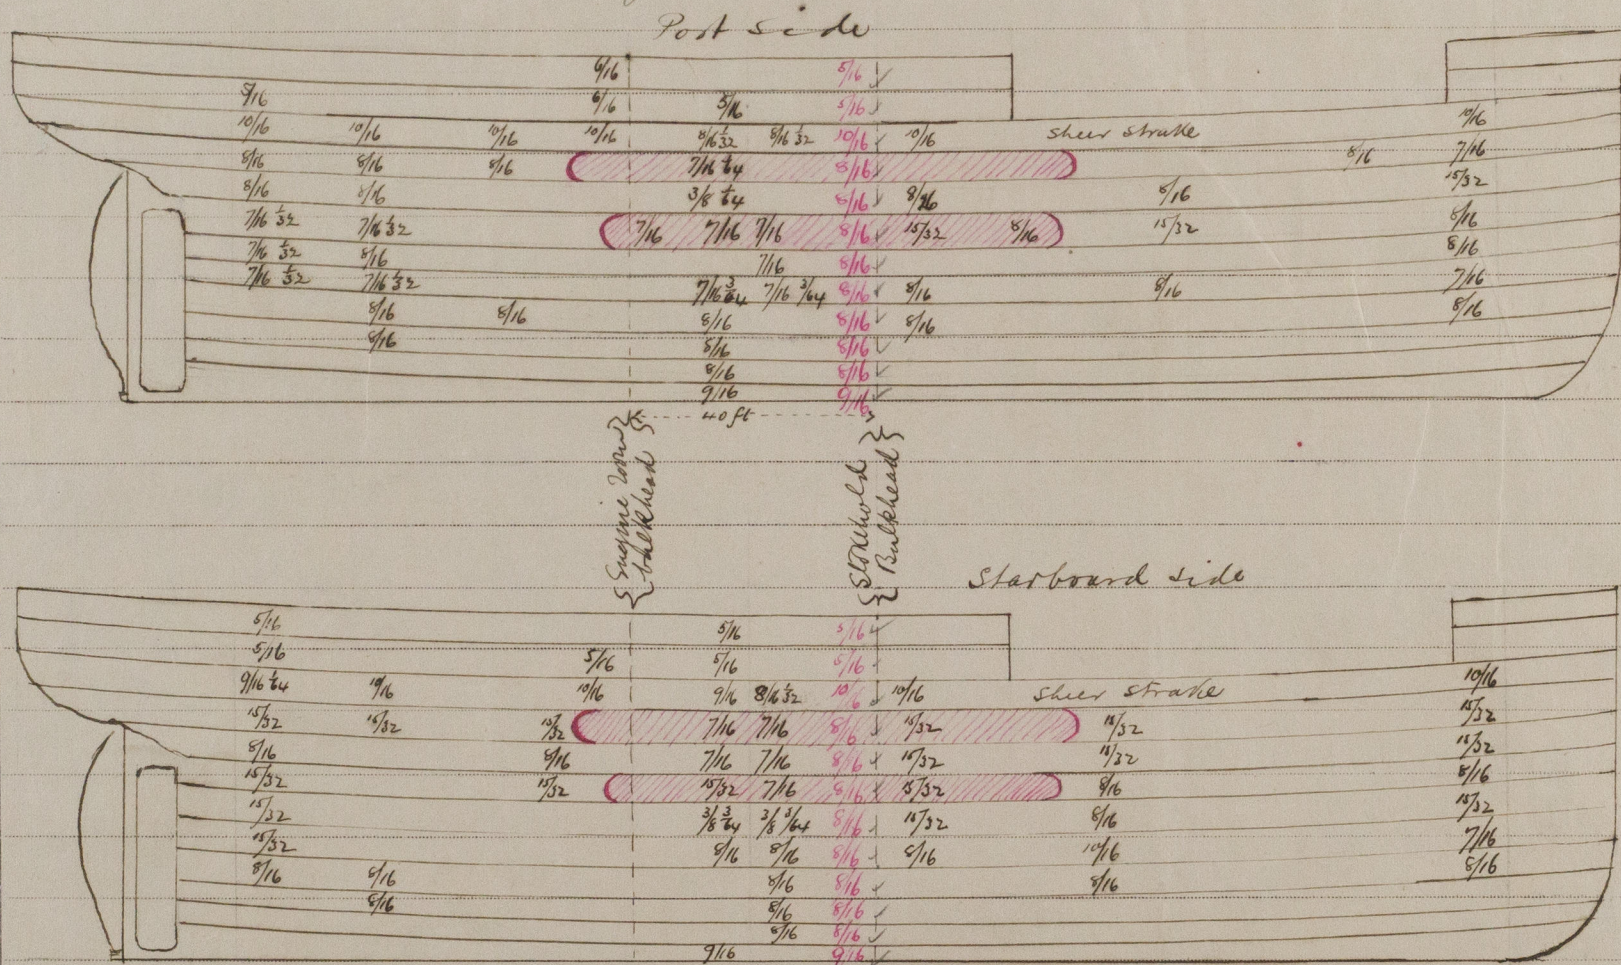
The plating drilled in three sections and elsewhere as per sketch. Decks drilled. The inside plating chipped bright.
