REPORT of SURVEY for REPAIRS, &c.

No. in Reg. Book. Survey held at London Date, First Survey 13/1/94 Last Survey 16/1/1894

580 on the Wood, Iron or Steel Ss Michigan Master Layland

TONNAGE:— Built at Belfast By whom Harland & Wolff When 1890-6

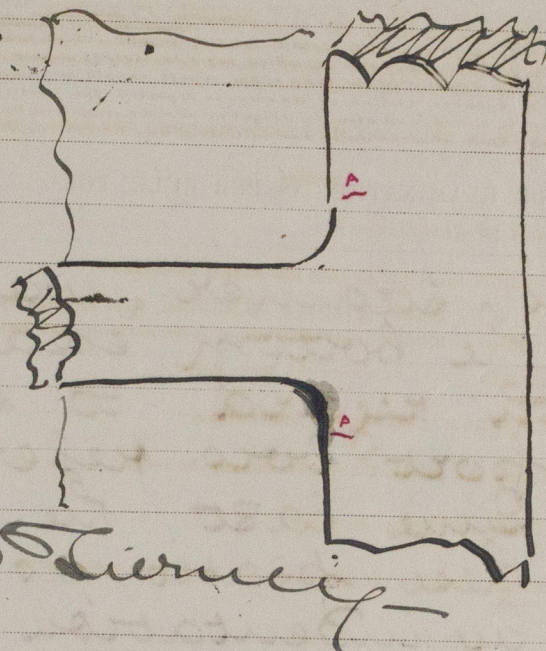
On the Starboard side of the Cast Steel Rudder frame, ~~two~~ slight flaws were carefully inspected at lower part of Rudder, they appear to be original defects in the casting, they are slight in character on edge of casting, & have not altered in any way. The rudder is in my opinion quite efficient.

Section Flaw

A position of defect

Caused from turning
