# REPORT of SURVEY for REPAIRS, &c.

on the ~~Wood, Iron or Steel~~ S.S. "Minnesota"

TONNAGE:— Built at Belfast By whom Harland & Wolff When 1887 MONTH 11  
GROSS 3216 Owners Atlantic Transport Co (Lim) Port belonging to London  
UNDER DK. 2988 Owners' Address Tilbury  
NET 2080 (if not already recorded in Appendix to Register Book.)  
Surveyed Afloat or in Dry Dock? Afloat Name of Dock Tilbury Destined Voyage

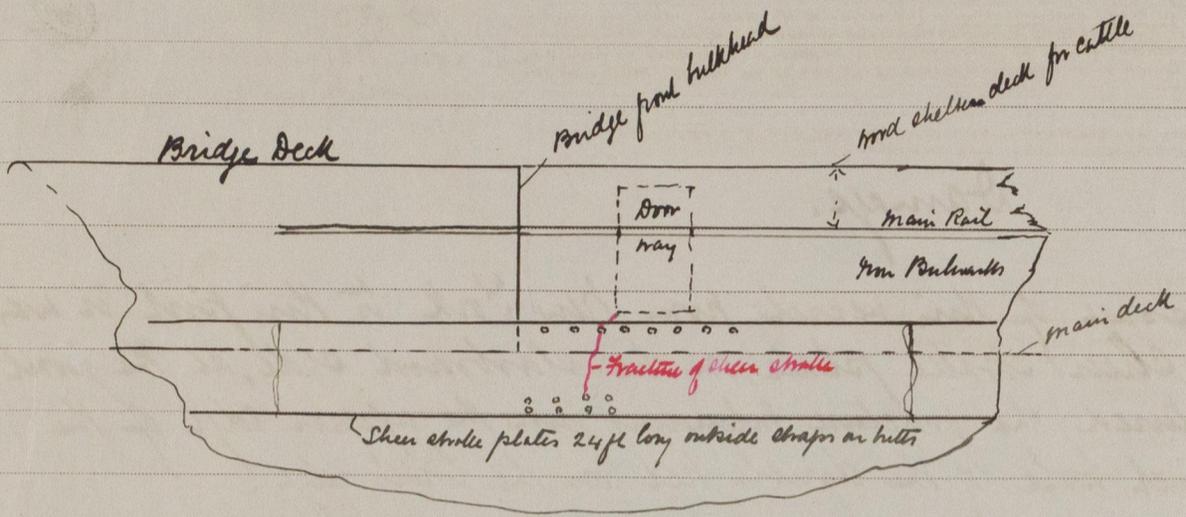
During this last passage of this vessel from New York to this port, it was discovered that the sheer strake plate, on the starboard side, at the front of the bridge was fractured, the fracture extending from the upper edge of the plate to the upper rinch hole of the double tier on the lower edge.

A rough sketch on the other side is given to show position. No special reason is assigned for this fracture, its discovery being due to the fact that water was observed running down from this plate into the tween decks, & means had to be taken to prevent this.

In view of the possibility that the plate itself was faulty test pieces are being prepared for proof.

The plate has been cut off; a new plate—tested in accordance with the Society's Rules—has been fitted. In addition to this, at my request, a doubling plate 20 feet in length has been fitted on this side in way of the bridge post. I have suggested to the owner the advisability of fitting a similar doubling

on the port side; but as there is no sign of failure there, they have not fitted it, but will probably do so when the vessel comes on for the next special survey.

The lap joint of the main deck stringer plate at the bridge post on the same side of the vessel has been re-riveted
