REPORT of SURVEY for REPAIRS, &c.

492 on the Wood, Iron or Steel Ship "Pleiades"
TONNAGE: Built at Barnaburton By whom A. M. Brillon & Co. When 1869 9
GROSS 1020 Owners Shaw Savill & Albion Co. Port belonging to Southampton
UNDER DE. 935 Owners' Address
NET 997 (If not already recorded in Appendix to Register Book.)
Surveyed Afloat in Dry Dock? Name of Dock Green's Dry Dock Destined Voyage New Zealand
WB=CellDBorDBa tons; uE&B tons; f tons; }
FPT tons; APT tons; MT tons. }

Iron Ship "Pleiades"

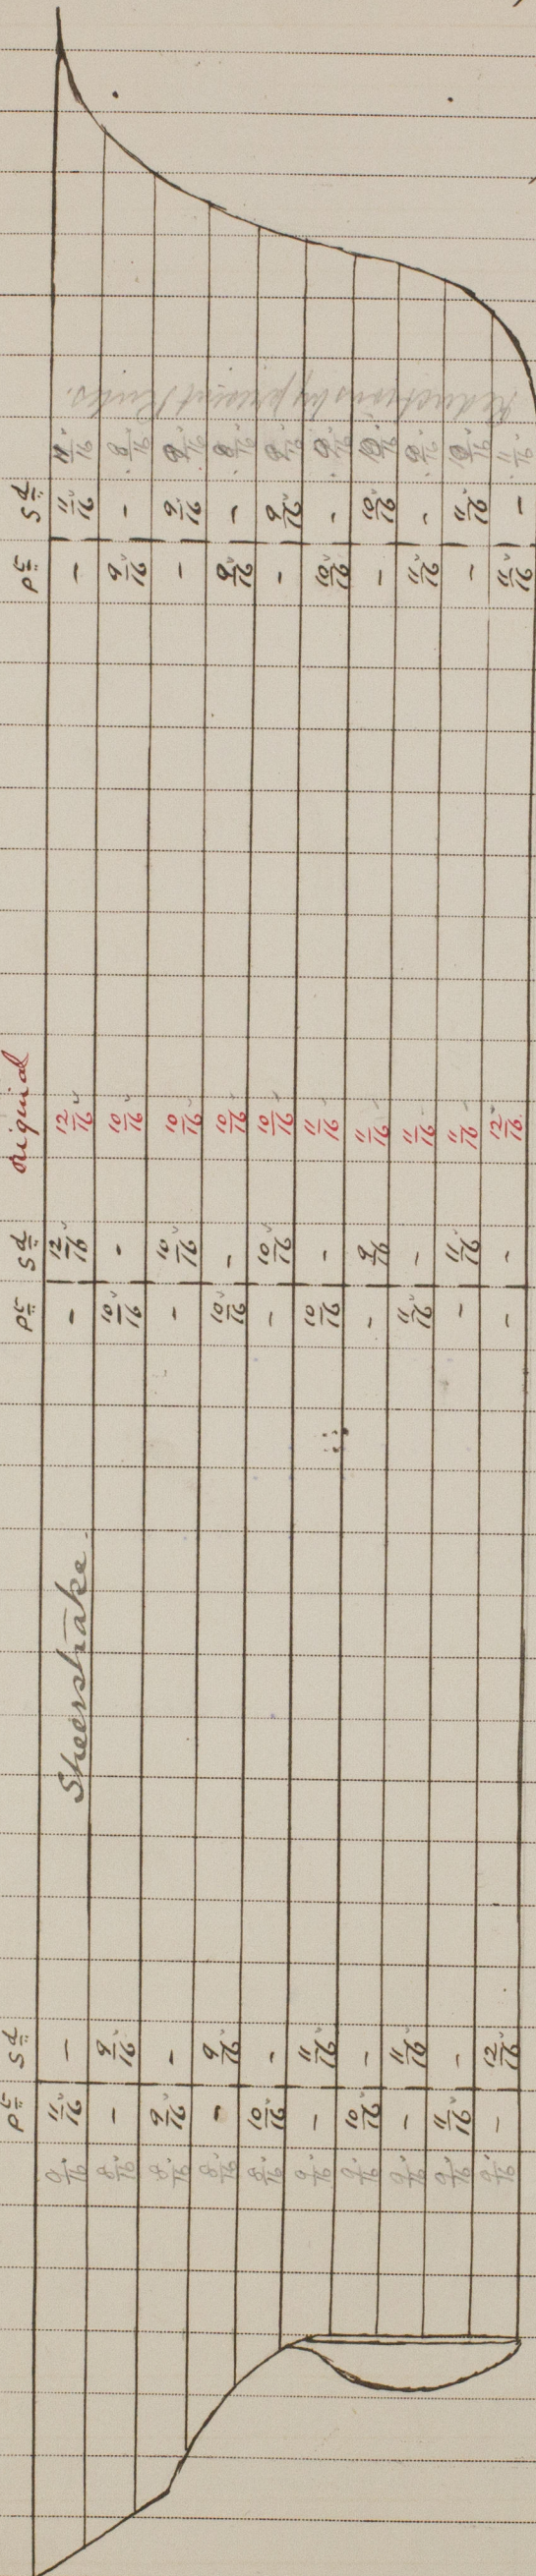
The plating drilled in three sections on each side and the thickness found to be as given on sketch herewith.
