## REPORT of SURVEY for REPAIRS, &amp;c.

Port of London

PERI

REPAIRS, OR EXAMINATION AS PER RULE, FOR Special Survey No 3

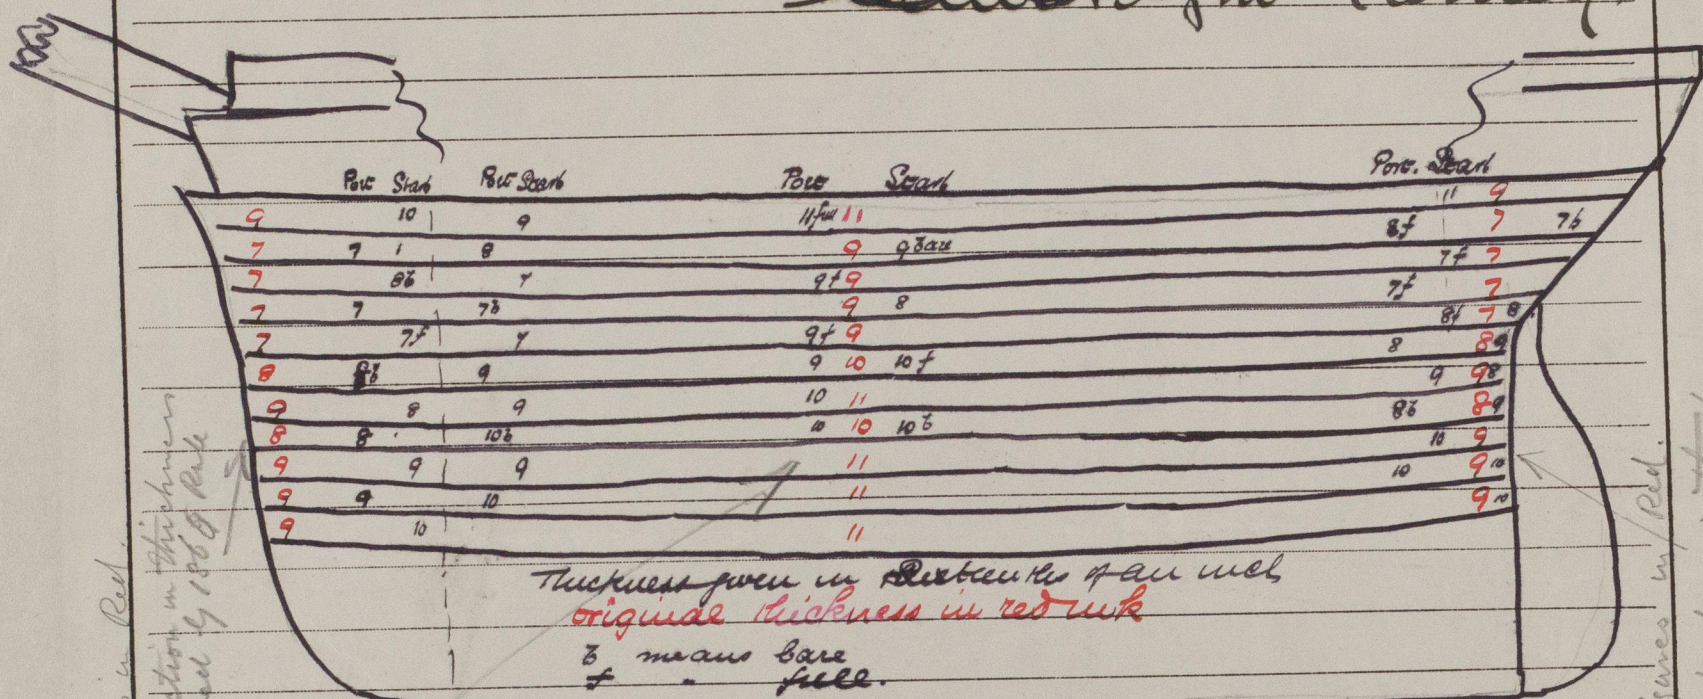
Rough Sketch showing thicknesses  
of shell plating ascertained  
by drilling

The thickness of the shell plating ascertained by drilling in various parts as shown by sketch attached.

Figures in Red.  
Reduction in thickness  
allowed by 1868 Rule

Above thicknesses in Red compared  
with 1st Entry Report.
