REPORT of SURVEY for REPAIRS, &c.

No. in Reg. Book. *Survey held at London* Date, First Survey *1st April* Last Survey *8th May 1886*
815. on the *Steel Screw Steamer "Lydian Monarch."* Master *Huggett.*

Damage sustained by fire and water at New York

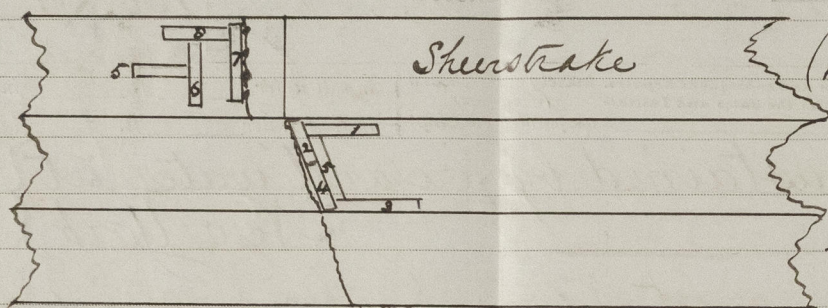
vessel, the sheerstrake and two plates below were found broken as marked on accompanying sketch. And on the 20th March another report was heard, and one plate of the doubling on lower part of shelter deck side plating was found broken, and the butt of sheerstrake underneath it, open, and the strake below the sheerstrake broken down about 3" below the lap of plating. Other plates were also found broken as will be seen on the accompanying sketch. Of these broken plates tests have been made

The first piece tested was (No 7) sheerstrake plate cut close to the fracture, across the plate. This piece broke at 25 tons per in with no elongation, owing to a flaw in the piece - this piece was unannealed

The second piece tested was (No 8) ^{test} annealed, tensile strain 30.6 tons per in elongation 25.6 % - 3rd piece (No 6) annealed, - tensile strain 30 tons per in, with an elongation 26.75 % - 4th piece (No 5) annealed tensile strain 30.54 tons per in elongation 29.6 %.

We then subjected the broken plate next below the sheerstrake to tests cut as marked above. - (No 1) annealed, tensile strain 30.58 tons per in elongation 26 % - (No 2) annealed - tensile strain 30.5 tons per in elongation 26 % - (No 3) unannealed - tensile strain 30.66 tons per in elongation 25.5 % - (No 4) unannealed, tensile strain 30.75 tons per in elongation 25.5 % - (No 5) unannealed tensile strain 30.25 tons per in elongation 31 %.

The temper tests and likewise cold tests have also proved satisfactory - All the plates which have been removed and replaced have been annealed - thereby in our opinion disposing of any doubt which may have otherwise arisen as to their efficiency

Some curious matters developed themselves during the removal of the buckled plates - In the thin (6/16") plating of the shelter deck, 3 plates, 6 D, 12 D, & 14 D, were found broken under the butt straps of the thick doubling strake, and two plates of the sheerstrake 13 C & 18 C were discovered to be broken as shown on the sketch, while being unwrinkled - no sign of a fracture being seen before the unwrinking commenced
