Steel S.S. Lydian Monarch

In submitting the accompanying report of repairs just executed on the above named Steel Vessel, we also beg to lay before you a historical sketch of the case, as there are several points of interest connected with it, which we feel assured the Committee will be glad to be possessed of.

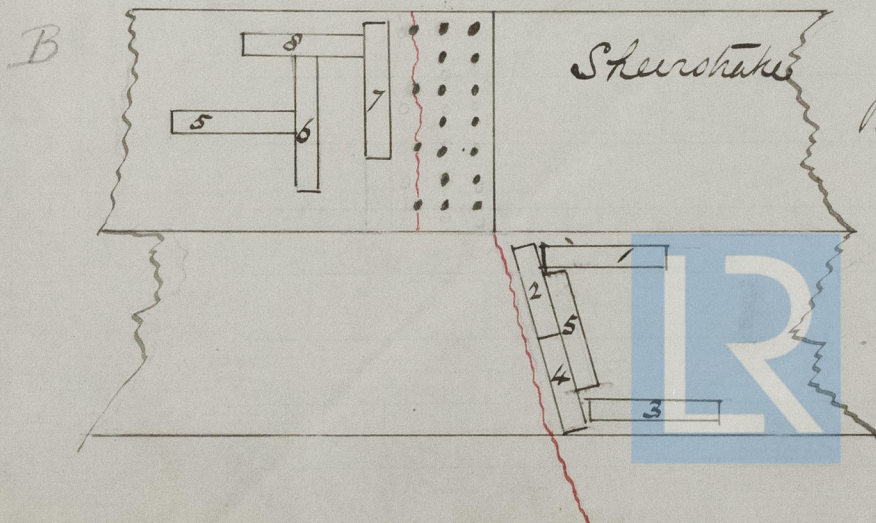
Breaks of the
19th March.

She left New York on the 17th March, and on the 19th - the ship then plunging heavily, a loud report was heard, and on an examination being made, the sheerstrake and two plates immediately below were found broken (see accompanying sketch) on the 20th another report was heard, and then about 24 feet further aft, the doubling strake at lower part of the shelter deck plating was found broken, the butt of the sheerstrake immediately below the break, open, & the strakes below broken at the upper edge about 6 in down.

It will also be seen on reference to the sketch, that the breaks in the plating are in immediate proximity to the butts of adjacent strakes or the butts of stringer plates.

After the broken plates were removed we subjected 8 C and 9 B to tests and had the pieces cut off as close as possible to the fractures as here shown.
