Proposed plan for stiffening the corroded parts in Coal bunkers of the SS Elena D.

24 June 1905

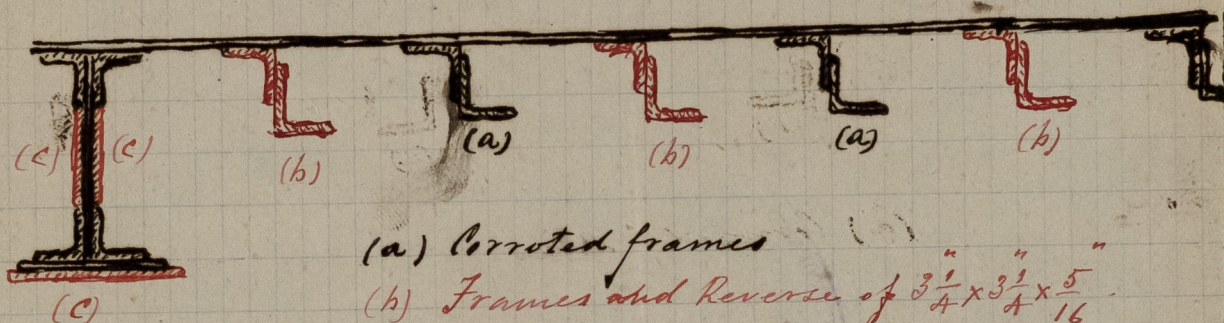
(a) Corroded frames

(b) Frames and Reverse of  $3\frac{1}{4} \times 3\frac{1}{4} \times \frac{5}{16}$

(c) Rider plate & doubling rivetted on web frames considered corroded
