Lloyds Register of British
and Foreign Shipping.

LLOYDS' REGISTER,

9th December 1891

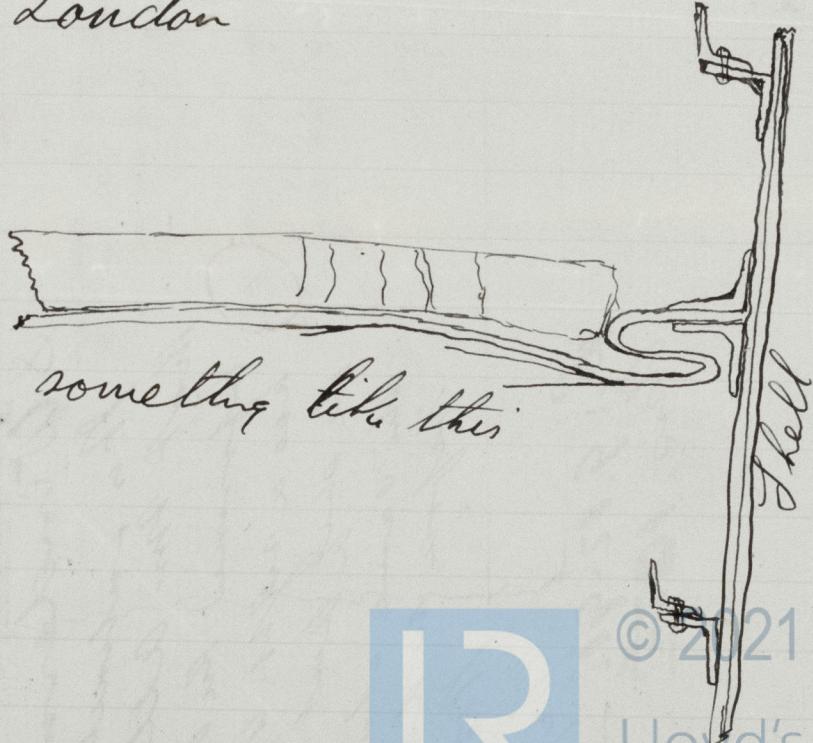
I went on board the Windermere after she was moored yesterday also this morn'g for the purpose of seeing what damage she has sustained by striking the dock head while entering yesterday. As they have no stage rig'd and cannot rig one very well as they are going to run her and put her in to dry dock today I cannot see the outside damage but from what I see inside two of the shell plates will have to come off and be reset. She has taken the Pier right on the collision Bulkhead and stoned it in about 6" setting in one frame forward and one frame aft about 2 to 3 inches the two frame angles on Bulkhead are drove straight in and broken from inner edge of web to rivet hole the plate itself drove into an S the horizontal bar is buckled but with the exception of the two frame angles there is no sign of any other break. I cannot make out my report untill I see the outside With the frame angles on bulkhead I intend

I have drawn the
frame angle straight
it ought to be bent as ticked
in but its nearly to shore the
break. it is not past the
rivet hole and I think if it went well back
to place it would be better than cutting out

to let one of them remain will have it set back into place and a cover angle put over the break the one on the other side might be done the same thing with if we can get it out properly if not it must be cut out at a fair shifting and two cover angles put on Will you kindly give me your advice on this at the back I give a rough sketch of Balkhead
I am, Sir,
