## REPORT OF SURVEY FOR REPAIRS, &amp;c. OF ENGINES &amp; BOILERS

Continuation of Report No. 7272 dated 24<sup>th</sup> October, 1946 on the

T.S.S. "PANAMANIAN"

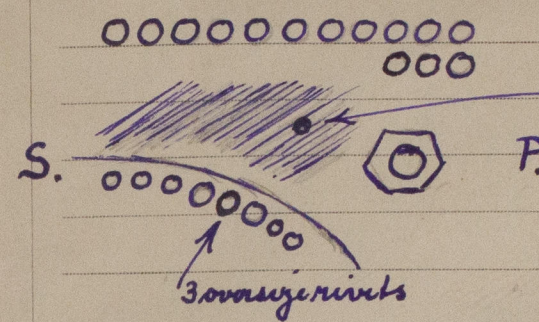
Starboard double ended boiler: The after tube plate in the port side combustion chamber of this boiler was found to be badly bulged between the lowest row of tubes and the furnace flange; the forward tube plate was also bulged but to a lesser extent. Three rivets in the furnace flange had obviously been removed and there was a screwed plug in the bulged plating which seemed to indicate that some action had been taken in connection with the defect at an earlier date. There were, however, no records on board the vessel and it was considered necessary that the defect be dealt with before the boiler was again put into service.

Rough view looking aft in port combustion chamber.

area affected by bulging - maximum depth is about  $\frac{5}{8}$ " and is to starboard side of screw plug.

The machinery of this vessel is eligible, in my opinion, to remain as now classed in the Register Book without fresh record of survey subject to the after tube plate in the port combustion chamber of the starboard double ended boiler being reinforced or otherwise dealt with before the boiler is used again and to all outstanding requirements being dealt with as previously recommended.
