REPORT of SURVEY for REPAIRS, &c.

on the ~~Wood, Iron or Steel~~ Twin Sc. Sch. "AAR V"

REPAIRS, OR EXAMINATION AS PER RULE, FOR SPECIAL SURVEY 2ND N°3 FOR RECLASSIFICATION-

of GENOA Continuation of Report No. 42481 dated 23/1/33. on the "AAR V"

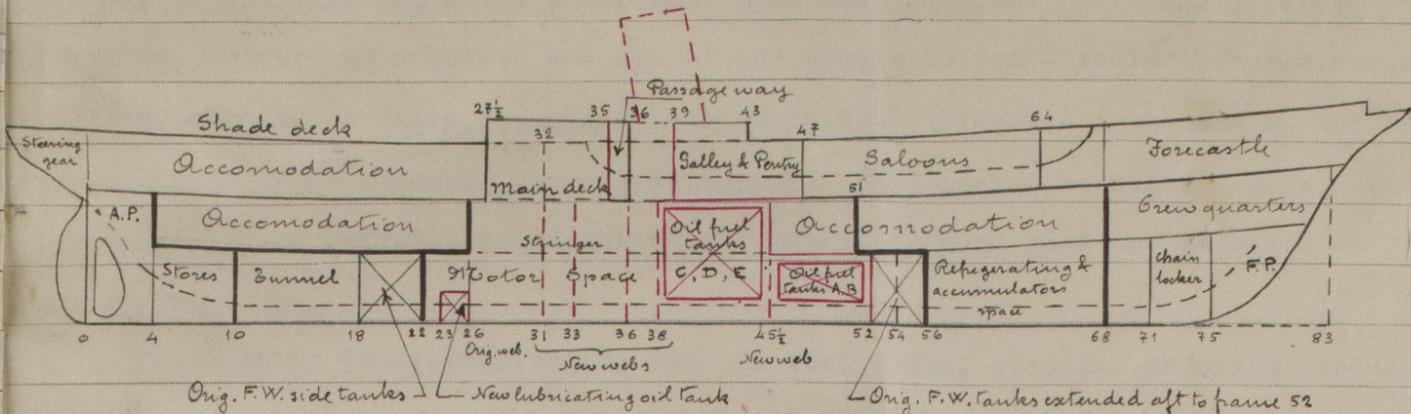
Alterations carried out at Hamburg by Blohm & Voss in 1931 shown red.
Watertight bulkheads & flats shown in thick black lines.

2nd deck extended from frame 51 to 45½ and made gas tight.

c) New oil fuel tanks- Five tanks, entirely electrically welded, built separate from the vessel's structure and placed in the forward part of the machinery space between frames 39-51. Floor on frame 38 made oil tight to provide suitable gutterway at the after end of the oil fuel tanks and a new suction from bilge piping, fitted in frame spacing 38 - 39.

dd) A small lubricating oil tank- built between floors 23-26, at the central part of the bottom.

A sketch of the profile of this vessel as converted has been designed above for Office record. Two plans dealing with the motor seatings and the oil fuel and fresh water tanks were approved in London on 2/12/32, and one copy of them is available in your office.
