REPORT OF SURVEY FOR REPAIRS, &c.

on the ~~Wood-Iron or Steel~~ Single Screw Steamer "HOPESTAR" Built at Wallsend By whom Swan, Hunter & Wigham Richardson Ltd. When 1936 - 2

REPAIRS, OR EXAMINATION AS PER RULE, FOR Damage stated to have been sustained through encountering heavy weather between 13th. & 21st. May 1947 while on a voyage from the Tyne to Montreal in ballast.

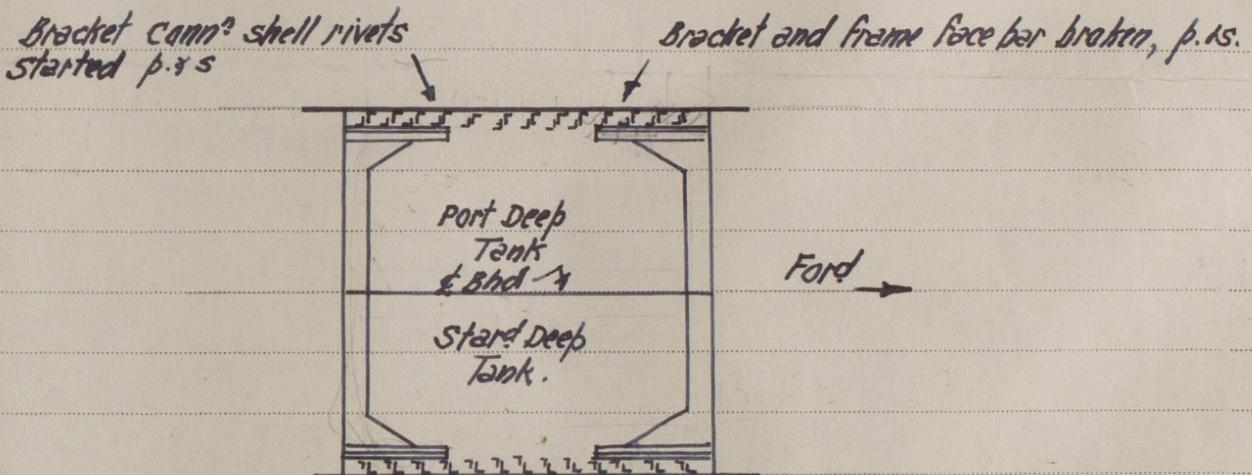
Plan at Horizontal Girder Level.

PORT DEEP TANK:- (cont'd.)

Horizontal bracket at forward end fractured at 4th frame from bulkhead and frame face bar broken.

STARBOARD DEEP TANK:- Three shell rivets started in horizontal bracket connection at aft end of tank. Horizontal bracket at forward end fractured at 3rd frame from bulkhead and frame face bar broken.

Part Permanent Repairs were effected as follows:- In port and starboard deep tanks:- three shell rivets renewed in all horizontal bracket connections and remainder of bracket rivets hardened up. Forward horizontal brackets and frame face bars veed out, rewelded and 6"x1/2" doubling plate welded on vertical flange of face bars over three frame spaces.

As the deep tanks were prepared for carrying grain the above shell repairs were hose tested and found satisfactory.
