Lisbon 26th September, 1932

Nº.749

FREEBOARD REPORT S.S."ANGOLA"

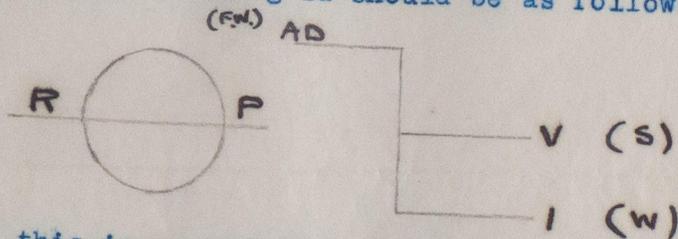
- 1) There is a slight mistake in the calculation of the Depth for freeboard, because either the thickness of the stringer plate is added, or  $\frac{T(L-S)}{1}$  when the value given by this expression is greater than the thickness of the stringer plate.
- 2) It is understood that effectively there is no allowance for tropical water, on account of the side lights which are at 25'4", but the omission of the winter freeboard mark is not justified.
- 3) The marks on the grid should be as follows:-

*As the freeboard had not been fixed by side light summer beam which would have been greater than the freeboard allowance  
No amendment*
