Lloyd's Register of Shipping.

SURVEYS FOR FREEBOARD.

GRK. REPORT N° 23368

Ship's Name **KOMNINOS (EX. YACHT JEANNETTE)** Port of Survey **PORT GLASGOW**
 Official Number **1710.** Surveyor's Signature *W. Macmillan*
 Nationality and Port of Registry **PANAMANIAN. PANAMA.** Date of Survey **AUGUST. 1946**

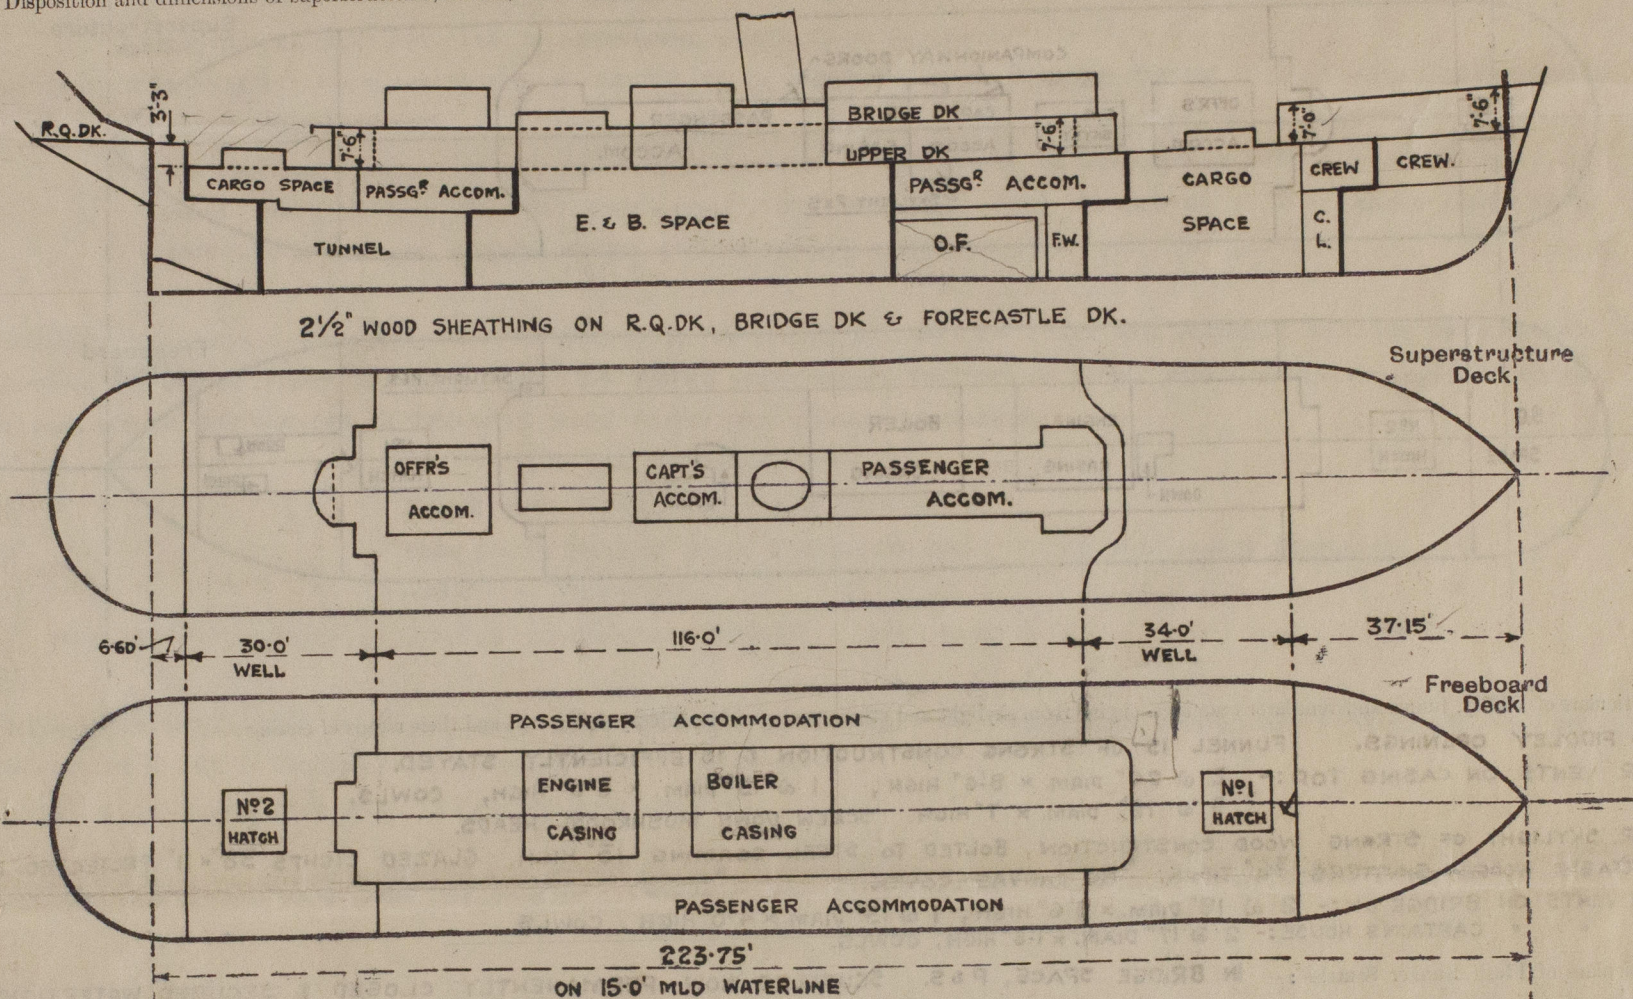
3" WOOD SHEATHING ON UPPER DK ALL FORE & AFT.

HEIGHTS OF SUPERSTRUCTURES ARE FROM TOP OF WOOD ON UPPER DK TO TOP OF WOOD ON SUPERSTRUCTURE DK.
