REPORT OF SURVEY FOR REPAIRS, &c.

Supp 67917 on the Wood, Iron or Steel S/T "SPANIARD" & "INKPEN" (No. of Visits 65)

REPAIRS, OR EXAMINATION AS PER RULE, FOR Reconditioning after Admiralty Service & Special Survey.

S/T. "SPANIARD" ex "INKPEN"

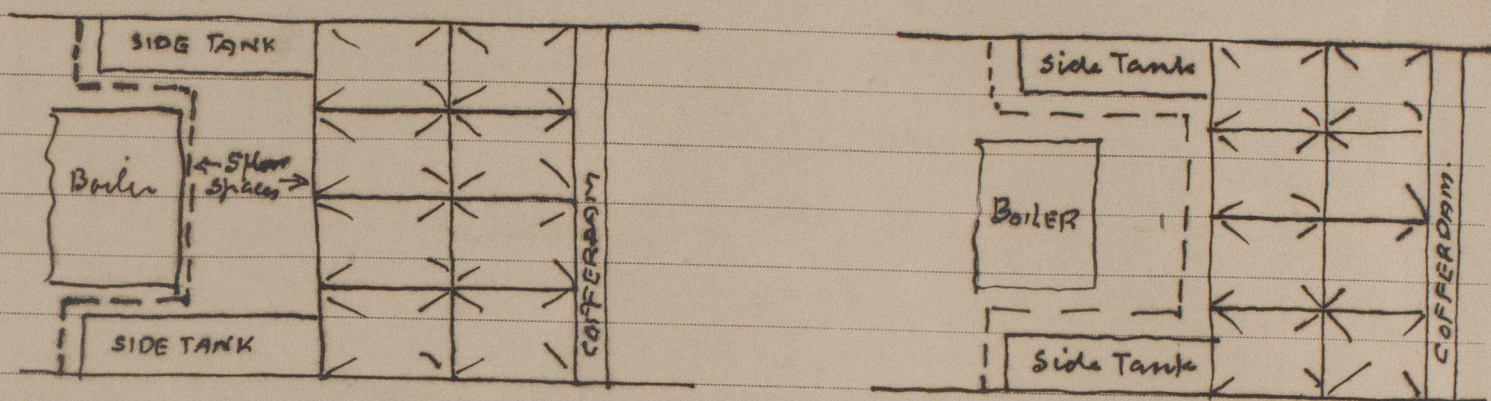
The requirements of Section 18 & 19 of the rules for steel trawlers, where applicable, for the burning of oil fuel having a flash point above 150°F have been complied with with the exception that the owners representative has fitted an oil bilge extending from the after bulkhead of the oil fuel bunkers to the front of the boilers (5 floor spaces) and guttermways as shown. The bottom of the vessel has not been cemented in these spaces. (reverse angles are fitted to the floors).

as fitted

as approved

The owners superintendent has been informed of the Society's requirements as detailed in your letter of 30th December but the arrangements have not so far been altered.

The vessel is proceeding to Hull for the fitting of superheaters and the owners superintendent states the oil bilge in the boiler room will be altered there.
