## Lloyd's Register of Shipping.

Ship's Name "STAL

Official No. 167586

Memorandum of alterations reported since ship was surveyed for assignment of Load Lines  
in 1932

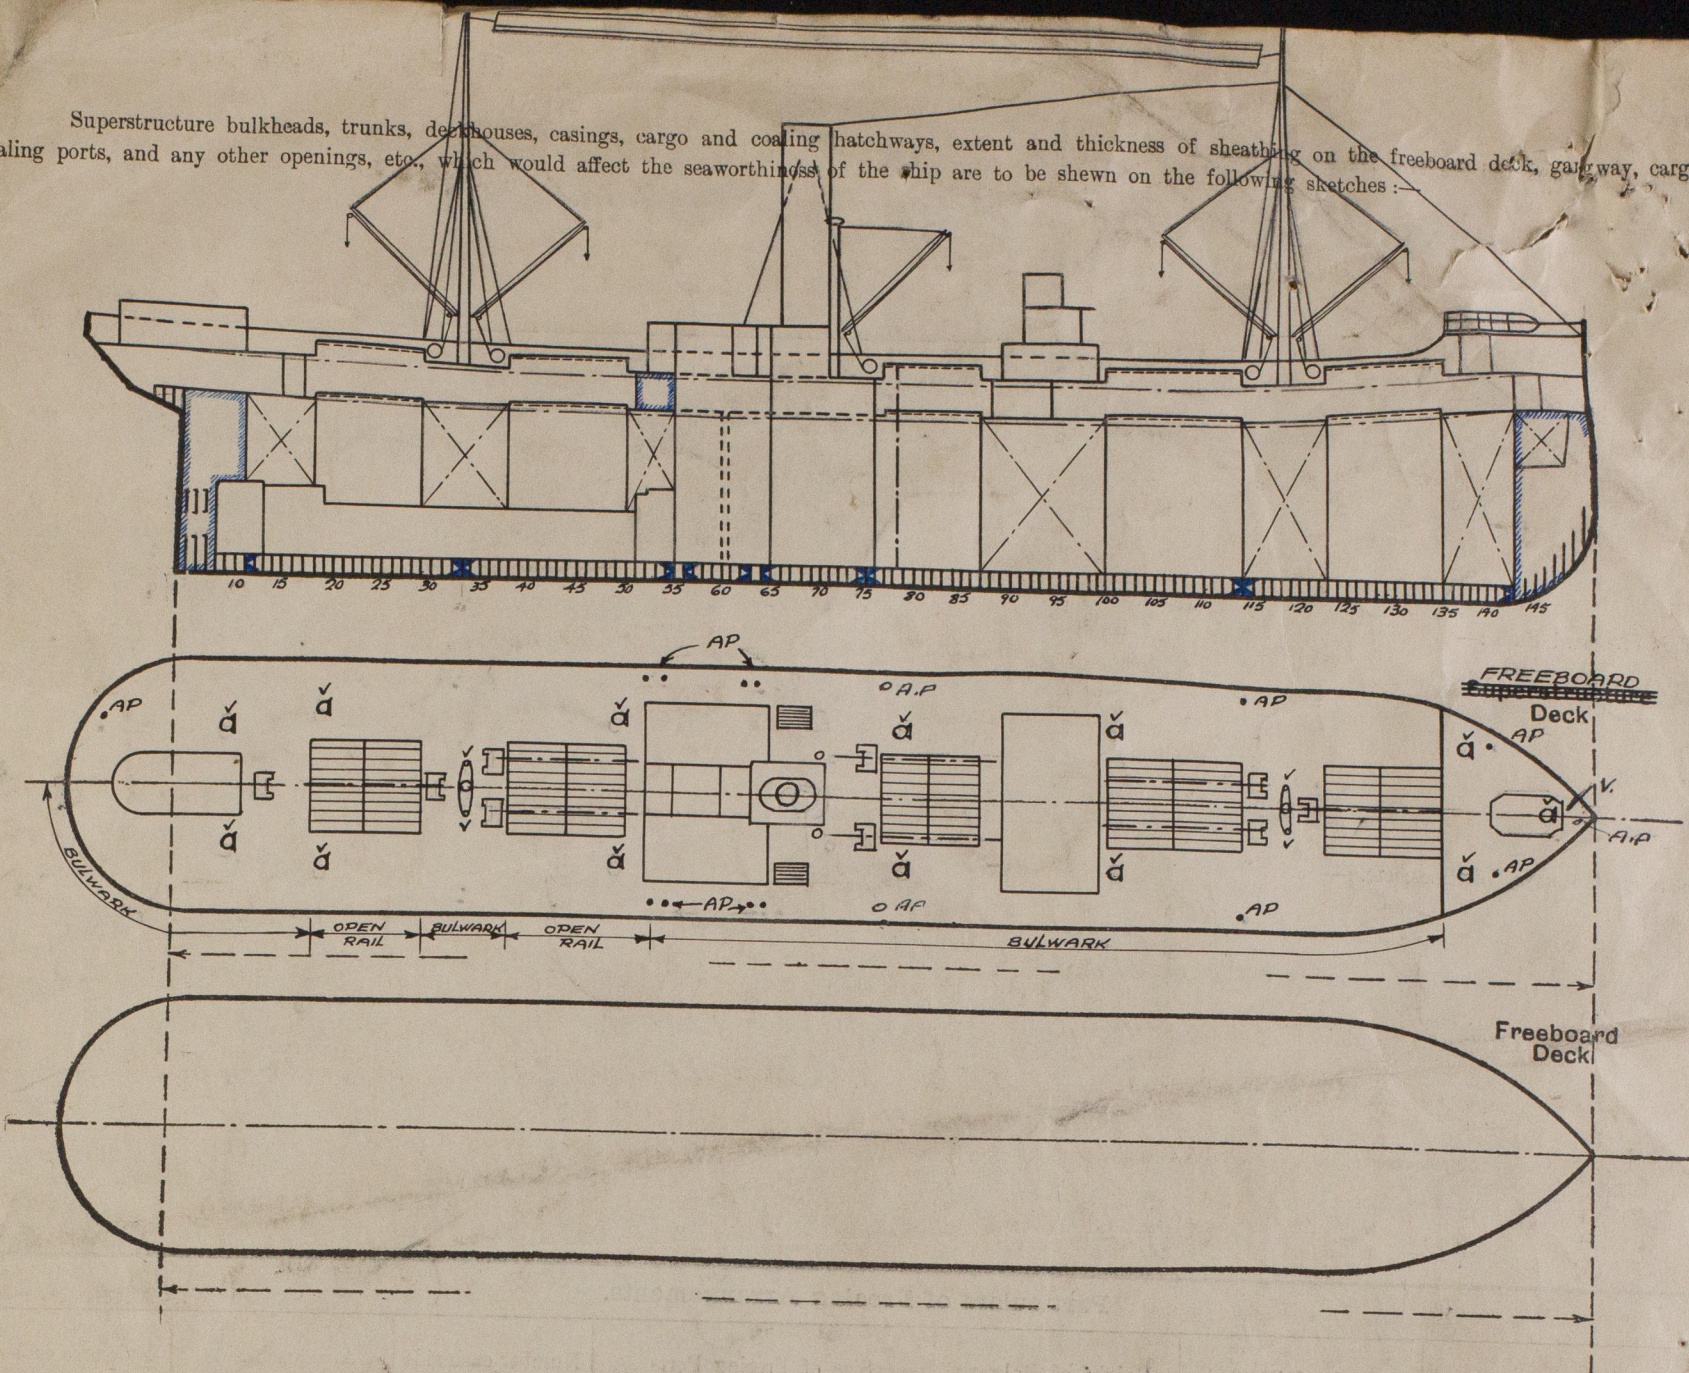
Superstructure bulkheads, trunks, deckhouses, casings, cargo and coaling hatchways, extent and thickness of sheathing on the freeboard deck, gangway, cargo and coaling ports, and any other openings, etc., which would affect the seaworthiness of the ship are to be shown on the following sketches:-
