REPORT OF SURVEY FOR REPAIRS, &c., OF ENGINES AND BOILERS

No. 134389

T.S.S. EMPRESS OF AUSTRALIA (cont'd)

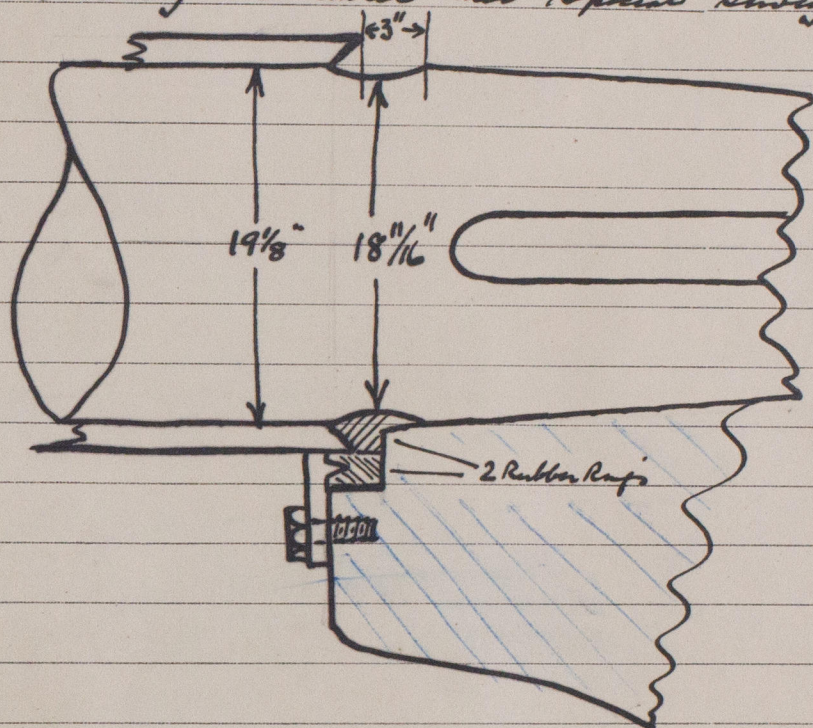
Docking:- Vessel placed in dry dock propellers and all outside fastenings examined & in order. All sea valves opened up, examined, minor repairs & renewals effected, condition now satisfactory. The starboard tailshaft was withdrawn and owing to corrosion at the aft end of the liner, was removed ashore for machining - the liner was cut back $\frac{1}{2}$ " and circumferential grooving machined out of the shaft at the end of the liner, the final diameter being $18\frac{11}{16}$ " (original $19\frac{1}{8}$ "). A spare tailshaft was not available and this shaft has now been machined as per sketch below, to enable vessel to carry on until her Special Survey in April 1952.

It is understood from the Owners Rep^t that the original S.H.P. was 10,000 and the R.P.M. 125. with a propeller diameter of 210" - this gives a Rule Size of tailshaft = 18.7 ". The machining is now done at 7,000 S.H.P. and 110 RPM - in view of these facts this shaft was considered efficient meanwhile. The cone end has been skinned and the propeller, which had been a poor fit, has now been satisfactorily rebbed.

is in my opinion eligible to remain as classed without fresh record of survey - Subject to the port and starboard L.P. turbine lower casings being examined before the end of 12.52. Also subject to the port and starboard tailshafts being re-examined at the Special Survey in April 1952 and being renewed by 12.52

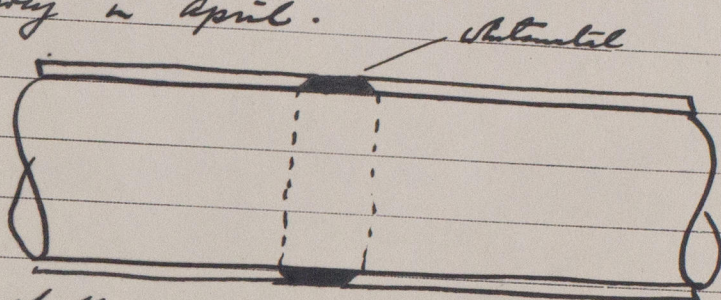
Close gauging of the cone end of this tailshaft showed that the small end of the cone was running out $35/1000$ " from the centre line, and on this account it was recommended that a further

Reading be taken at midlength of the shaft, through an inspection door in the stern tube. A reading taken at this point showed the shaft to be true but an examination of the liner in way of this inspection door showed the liner to be fractured circumferentially. The shaft was withdrawn, taken ashore and the fracture found to be at the junction of the two piece stepped joint liner. The liner was turned away to the bare shaft in way of the previous stepped joint and the shaft found satisfactory - after a through inspection and hammer test of the liners the ends were undercut (see sketch) and the junction filled in with white metal - this shaft then being considered efficient until the Special Survey in April.

Whilst the shaft was in the machine shop, the repaired and rebalanced propeller was tried on same, & rebalanced until a satisfactory marking with the key in position was obtained.
