Report of Survey for Repairs, &c., of Engines and Boilers.

Survey for Repair to Rotor of Port Main Turbine.

"EMPRESS of AUSTRALIA"

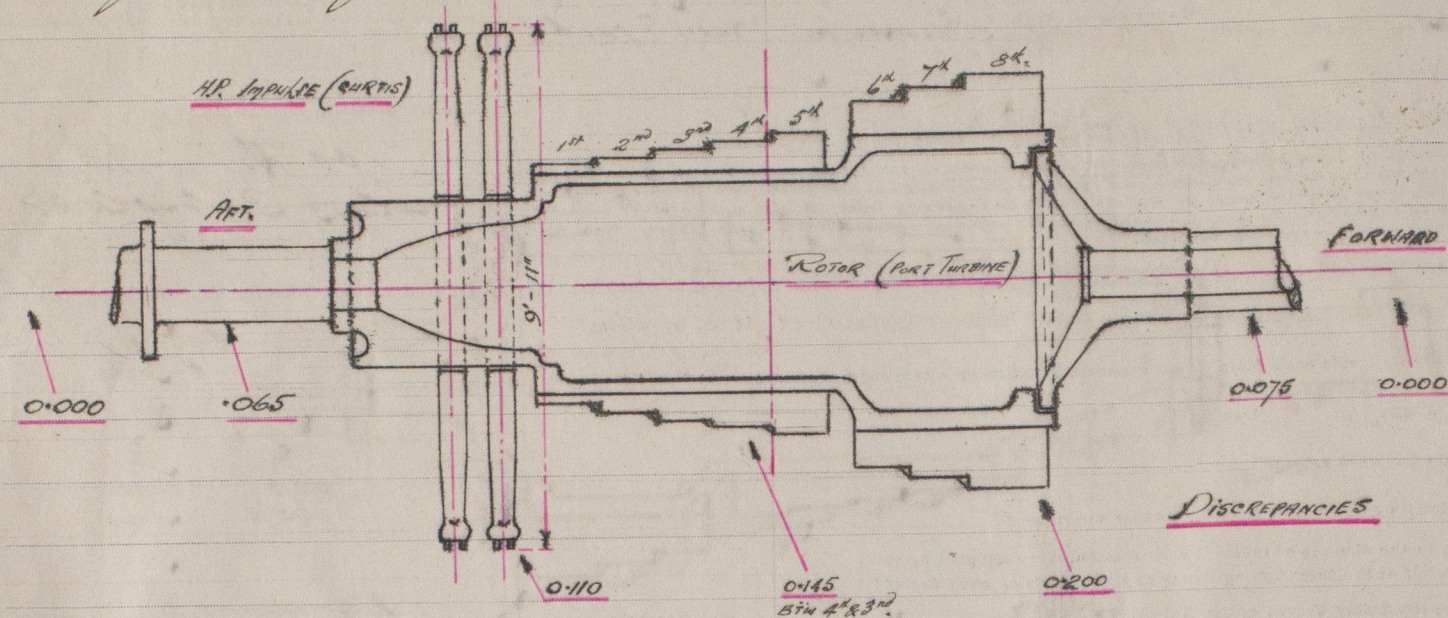
(1) Examination:- The Turbine being dismantled of its Connections to Casing was removed & Rotor lifted & transported to Lath Machine Shop for Examination. A Micrometer Reading throughout was taken at various points to ascertain location of Rupture. The measurements were found as follows:-

The shearing on Rotor blades also stationary blades at the 7th & 8th stages was badly rubbed & blades corroded where same had been in contact, due to whip in Rotor at this point. The Forward & After labyrinth packing and Diaphragm seal were badly damaged & Evidence of contact was very noticeable at joints between Expansion blades in 4th 5th & 6th stages, decreasing gradually to 7th stage. A noticeable Rub was noted on periphery of the S.P. impulse wheel flanges at diaphragm steam seal fit. Upon completion of check the Rotor was taken from Lath Centres & Dismantled. The Forward & After sections of Shaft & the Two S.P. impulse wheels were removed leaving Rotor a separate unit. At Forward End seven securing studs were found corroded up to as to permit them being moved by hand. & under hammer test all but four were considered sound. The threads in studholes were found stripped & the Flange faces for approx 90° circumferentially were found oxidised in way of loose scale - defining poor contact of surfaces. The Forward securing flange face of Rotor was sprung .080" & after face .012" out of square with Shaft axis.

The checking of Forward & After Shaft sections proved same to be within .003" perfect. In the After section a journal alignment variation of .011" was noted & that the labyrinth and packing cage fits on account of contact had increased their axial clearance to .080"

From the point of Rotor design we have a different view of things. Referring to sketch it will be observed that the Rotor is a large hollow steel Casting without any, or, in immediate interior strengthening, to span between journal supports being over 22 ft. (weight 2 1/2 tons).

(2) Repairs:- The Forward & After securing flange faces of Rotor, turned true and labyrinth packing cages connected to Shaft for Relativity. The studholes in after flange retapped .085" larger & new nickel steel studs fitted. The stud holes

in Forward Flange Retapped & Carried Right through flange. A set of new Nickel Steel Collar Bolts fitted with Lock nuts on spot faced surfaces & some electrically welded to bolt & flange. A new set of after nuts specially made & fitted. The labyrinth fins of After Casing removed & replaced by new & three of shaft re-rolled to original form. New diaphragm seal packing made & fitted & all loose leading in to 4th & 8th stages of both casing & Rotor as noted, was secured & shrouding brazed or fused necessary. For Main bearing top & bottom brasses & after main bearing top brass removed checked & re-bored for alignment & the joint faces machined to reduce oil clearance to .025. also stops fitted in housings to reduce bearing lift to a fixed amount.
