REPORT OF SURVEY FOR REPAIRS, &c.

Date of writing Report 14th DEC. 1948 When handed in at Local Office 14th DEC 1948 Port of GENOA
 No. in Reg. Book 63523 Survey held at GENOA Date, First Survey OCT. 19th Last Survey Nov. 25th 1948
 on the Wood, Iron or Steel MOTOR TANKER "JANKO" (No. of Visits 22)

TONNAGE: — Built at GOTHENBURG By whom A/B GÖTAVERKEN YEAR 1928 MONTH 11
 GROSS 9720 Owners PANKOS OPERATING CO. S.A. Owners' Address ✓
 UNDER DK 8976 Managers ✓ (If not already recorded in Appendix to Register Book)
 NET 5761 Port belonging to PANAMA

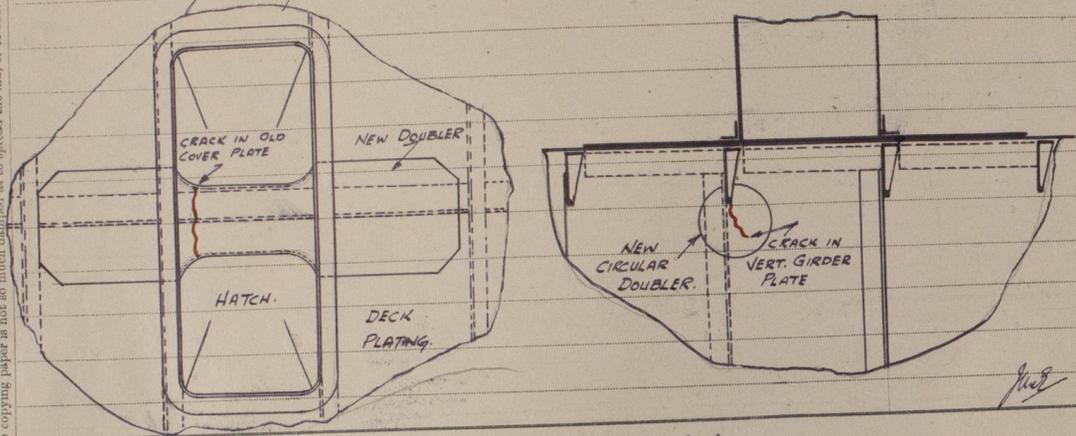
Damage (I) Stated to have been sustained by heavy weather on a voyage from Stockholm to Cebu from the 31st March to 4th Apr. 1948.

On examination the girder cover plate in way of centre hatches nos. 4, 5, 6, 7 and 8 was found cracked, and in some cases the vertical girder plate was cracked in way of slot for beam (see sketch).

Repairs now effected:- lower plates in way of these hatches removed, and new pieces fitted. On top of the cover plates and extending outside the hatches fore and aft a riveted doubling plate was fitted. The cracks in the vertical girder plates were weed out and welded, and a circular doubler fitted.

Repairs now effected to fractured deck girder in way of nos. 4, 5, 6, 7 and 8 centre tank hatches.
