REPORT OF SURVEY FOR REPAIRS, &c.

S.S. "KAIWARA".

REPAIRS, OR EXAMINATION AS PER RULE, FOR ANNUAL FREEBOARD SURVEY - DOCKING & REPAIRS - ALTERATIONS & ADDITIONS to HULL & SUPERSTRUCTURE - (WAR EMERGENCY) - LOAD LINE CERTIFICATE now ENDORSED.

DIAGRAM SHOWING EFFECT OF PROPOSED ADDITIONS TO THE NAVIGATION BRIDGE

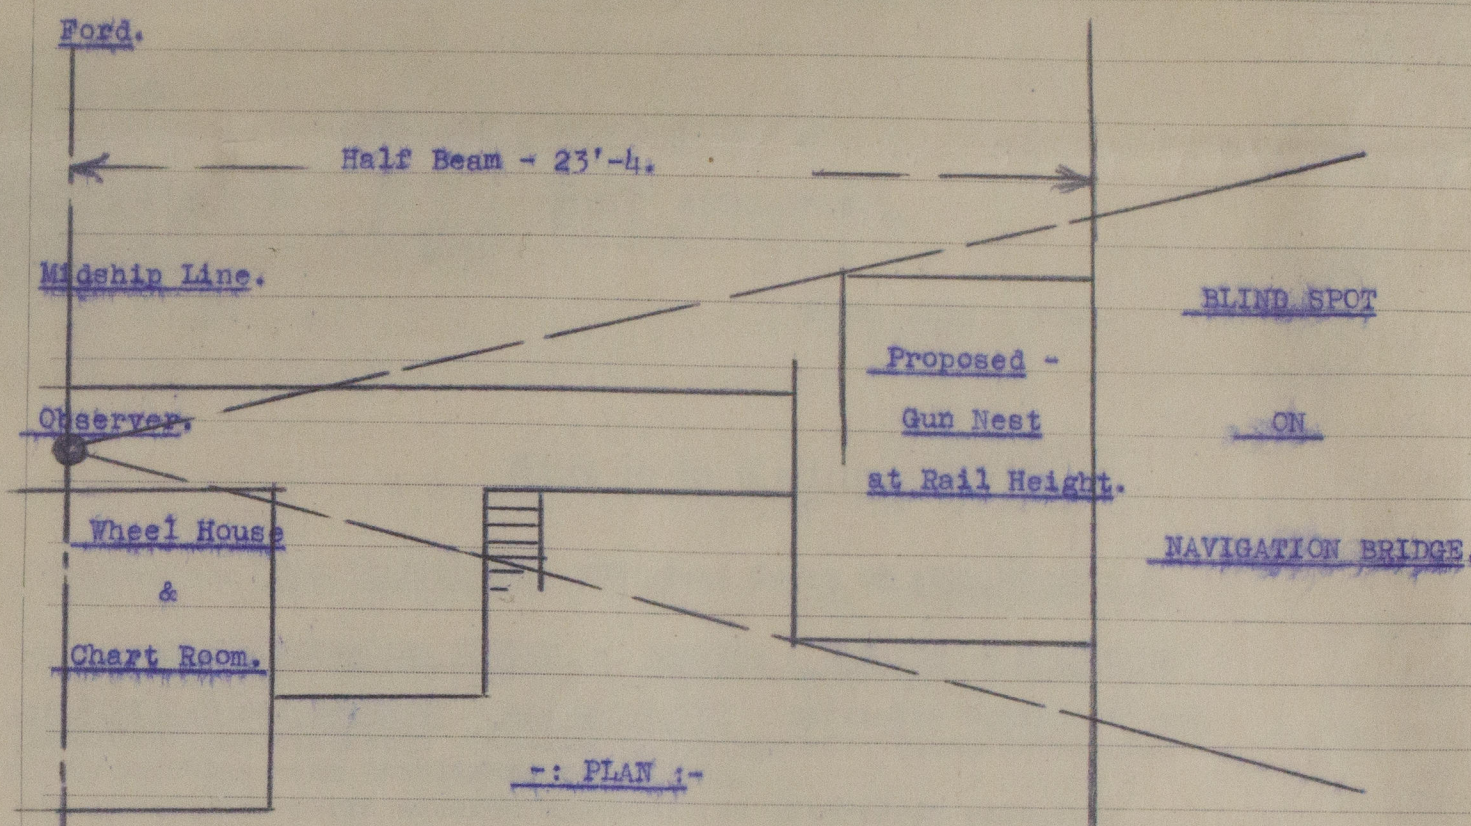
Rpt. 9a.

A proposal to fit additional structures permanently attached to the Navigating Bridge platform (Gun Nests) - interfering with both accessibility & visibility was not approved by this Office and made subject to a Recommendation - ~~THAT~~ - all added structures or defensive fittings are to be so arranged as not to impede either visibility or accessibility on the Navigation Bridge. (as per sketch - Ref. 9a. herewith).

Gun Nest fitted on Bridge Ends Port & Starb.
at Rail Height, obstructing vision

admidships.

RECOMMENDATIONS:- That all added Structures permanently - (not to scale).

attached or Defensive Fittings are to be so arranged as not to

impede either visibility or accessibility on the Navigation Bridge.

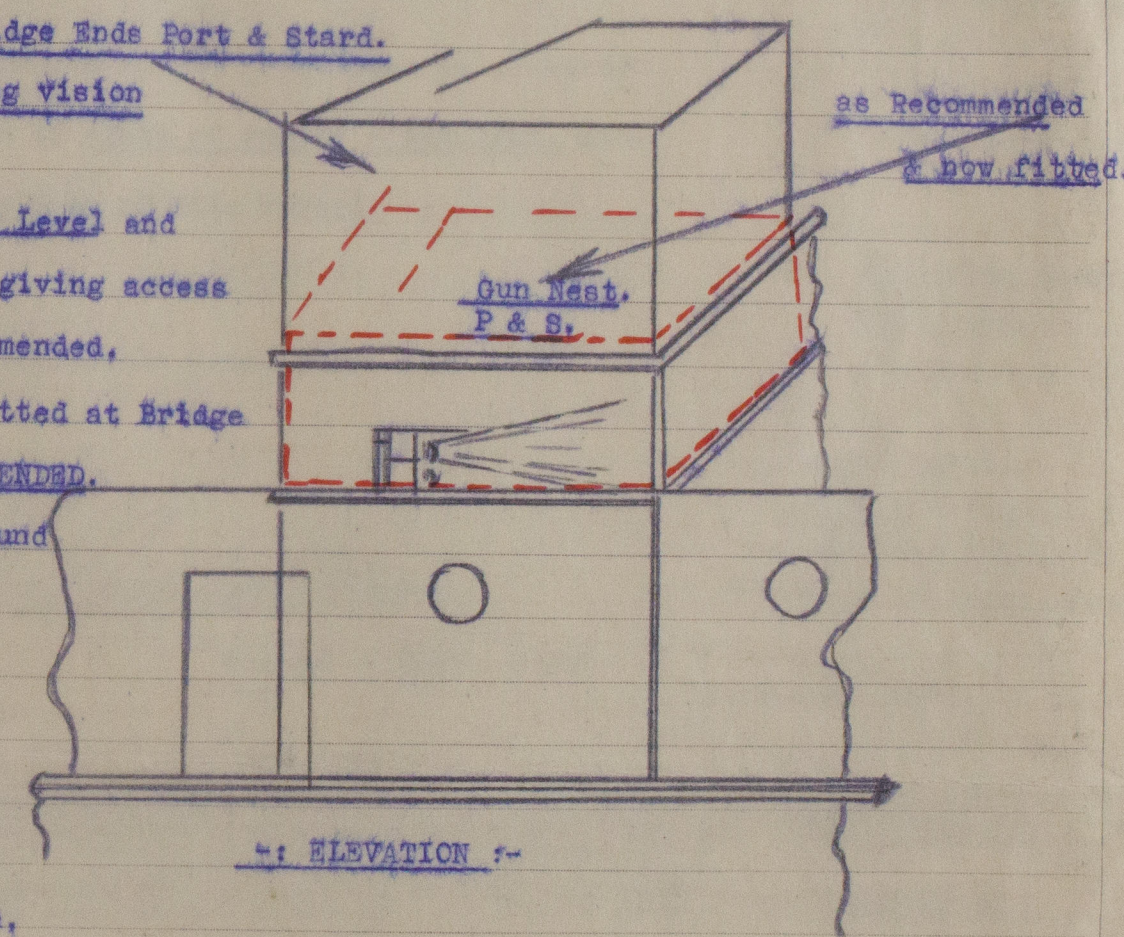
This Recommendation has been carried out to my satisfaction & the additional structures (gun nests) have been fitted at deck level giving free access to the ships' sides PAS & a clear view amidships.

Gun Nests lowered to Deck Level and
now permanently attached giving access
and clear vision as Recommended.

Position of structures fitted at Bridge
ends shown RED, as RECOMMENDED.

Position now approved & found
satisfactory.
