PLATES IN DK HOUSE
REMOVED FOR WASTAGE

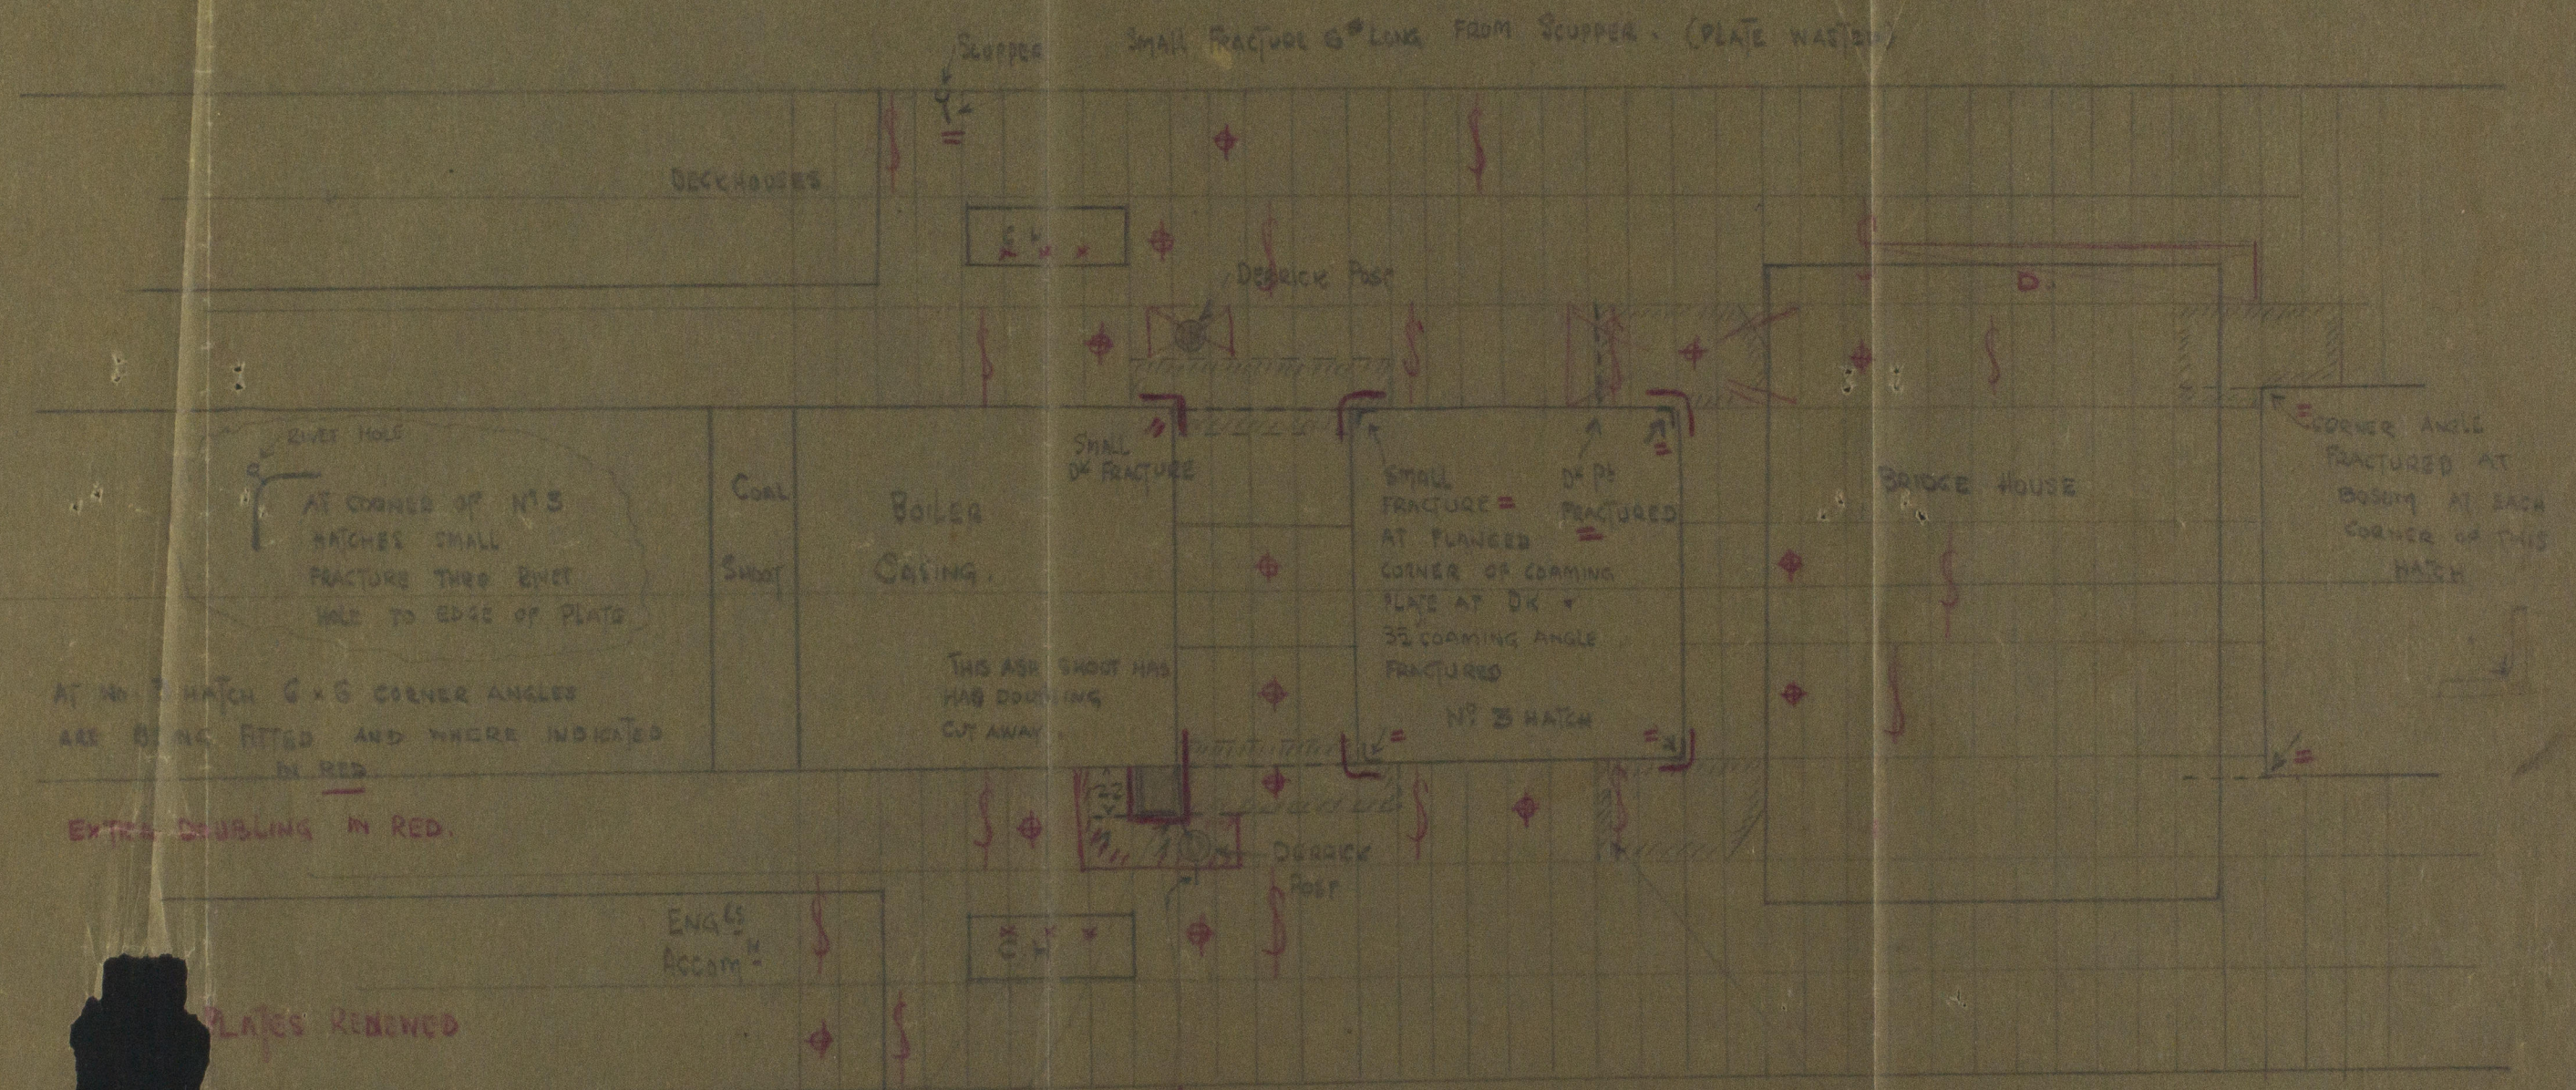
RIVET HOLE
AT CORNER OF NO 3
HATCHES SMALL
FRACTURE TWO RIVET
HOLE TO EDGE OF PLATE

THIS ASH SHOOT HAS
HAB DOUBLING
CUT AWAY

SMALL
FRACTURE =
AT PLANGED
CORNER OF COAMING
PLATE AT DK +
35 COAMING ANGLE
FRACTURED

CORNER ANGLE
FRACTURED AT
BOSOM AT EACH
CORNER OF THIS
HATCH

AT NO 3 HATCH 6x6 CORNER ANGLES
ARE BEING FITTED AND WHERE INDICATED
IN RED

EXTRA DOUBLING IN RED.

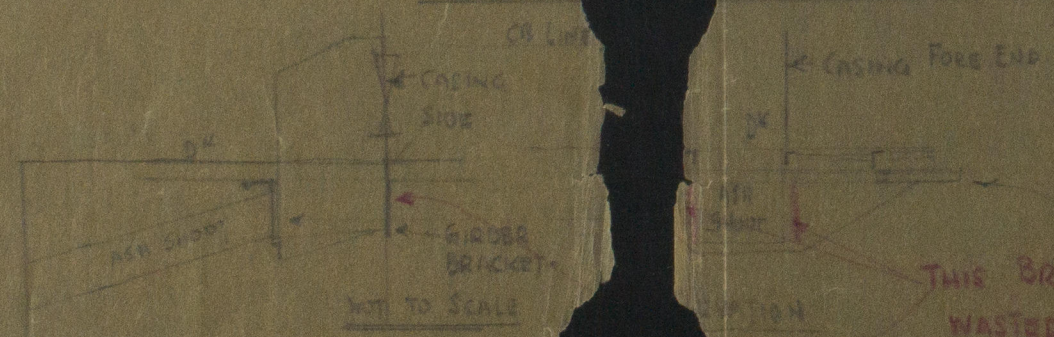
PLATES REMOVED

THIS BRACKET WAS
WASTED AWAY AT ASH SHOOT AND IN EFFECTIVE.

12" PLATING
BETWEEN SHOOT
AND OPENING
FOR POST

B.A. GIRDER ANGLE UNDER BEAMS

102
FRACTURE FROM CORNER OF
ASH SHOOT OPENING TO DERRICK
POST AND ACROSS PLATE TO 6" INTO
ADJOINING STRAKE. FRACTURE TWO
RIVET HOLES IN DECK RING (28" DIA)

BEAM AT 102 WASTED AWAY AT ASH SHOOT.

THIS PLATE HAS
FRACTURES ON SHELTER DK
HAD A DOUBLING
FITTED COVERING
PREVIOUS FRACTURE
