# REPORT of SURVEY for REPAIRS, &c.

Date of writing Report 7-4-37 When handed in at Local Office 7-4-37 Port of London  
 No. in Survey held at London & Gravesend Date, First Survey 25th Mar Last Survey 7th April 1937  
 Reg. Book. 87219 on the Wood, Iron or Steel M.V. "ARTHUR TOWN" (No. of Visits 6)

REPAIRS, OR EXAMINATION AS PER RULE, FOR Damage stated to have been sustained through Collision caused by an unknown craft with barge in tow off South River Thames during the night of 23rd March 1937 whilst on voyage London to Zeebrugge and fitting of Secondary Means of Steering and Rudder Brake - see previous Reports and Correspondance.

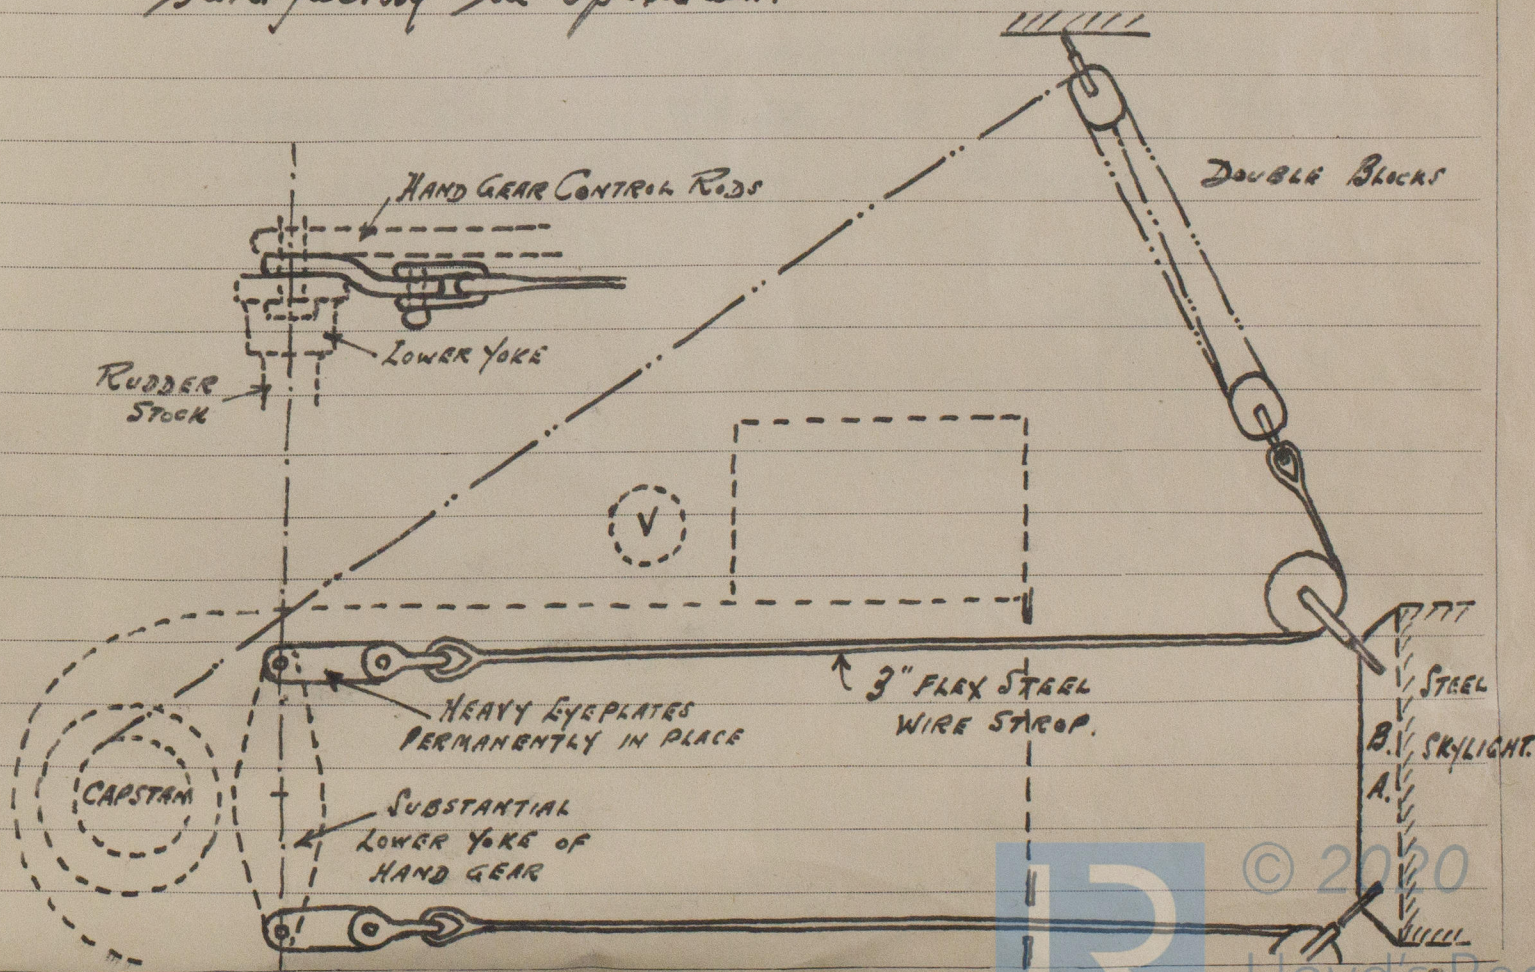
The vessel has been in continuous service since date of build, only in port for brief periods and then not always at places convenient for necessary dismantling relative to the fitting of the amended form of spare tiller and rudder brake, without interfering with current charters. It was desired to take full advantage of the present lay-up, consequent upon damage, for settlement of the outstanding items for class but, on examination of the new spare tiller and the place it was intended to occupy, it was found that it could not be fitted as it fouled the driving wheel of capstan and provided a lead which fouled 2 ventilators - alteration to the tiller or structure and fittings which meant further delay.

After careful consideration, use of this tiller has been dispensed with in favour of an amended arrangement as shown below, discussed with London Office Plans Dep<sup>t</sup> and provisionally accepted. This secondary means of steering has been fitted, tested and found satisfactory in operation.
